Bases for Predicting Occurrences of Rapid Corrosion on the Surfaces of Containers of C-22 at Yucca Mountain

**Presented at the Spring Meeting
of the NWTRB at Embassy Suites Hotel
Washington, D.C.
May 18, 19, 2004**

**by Dr. Roger W. Staehle
On behalf of the State of Nevada**

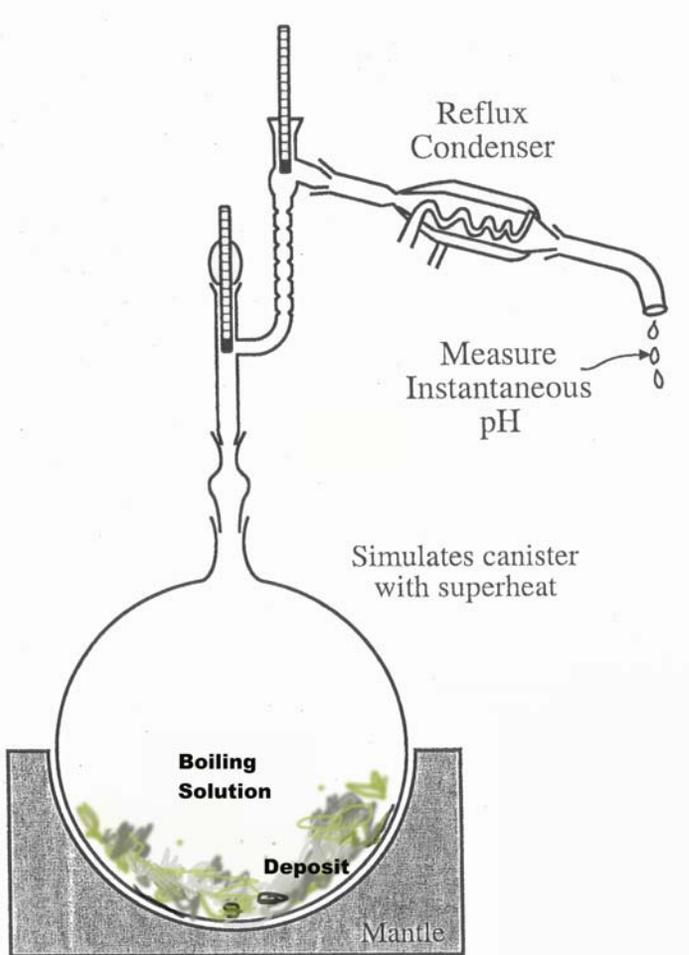
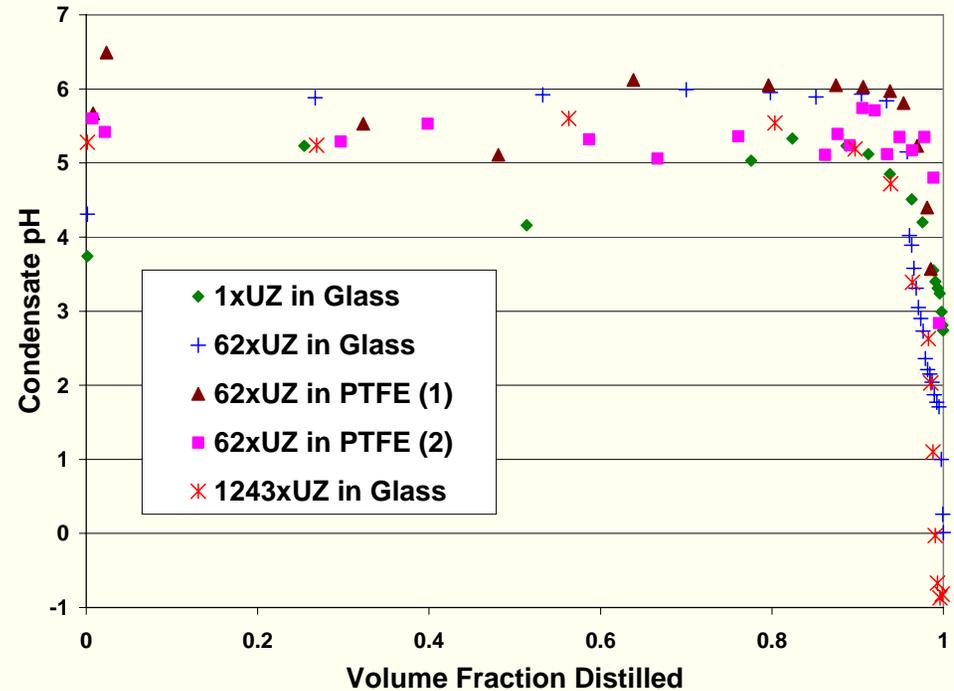
Distillation of UZ-pore Waters

Original Solution	Measured pH _{RT} of final dist.	Test temp °C	Corrosion rate of C-22
62xPore	0.59	130	406
1243xPore	-0.54	90	603

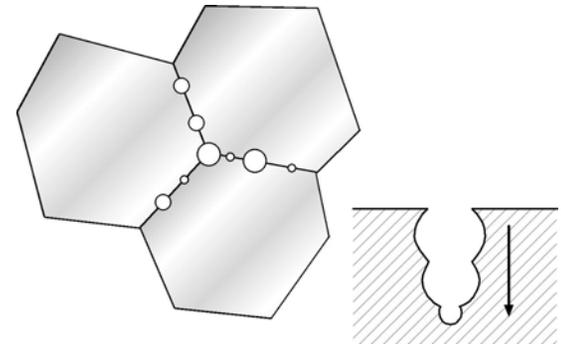
3. Preferential localized corrosion with re-nucleation at grain boundaries (structural)

- Variation on #2 but starts at grain boundaries.
- Multiple events destroy integrity of grain boundaries.

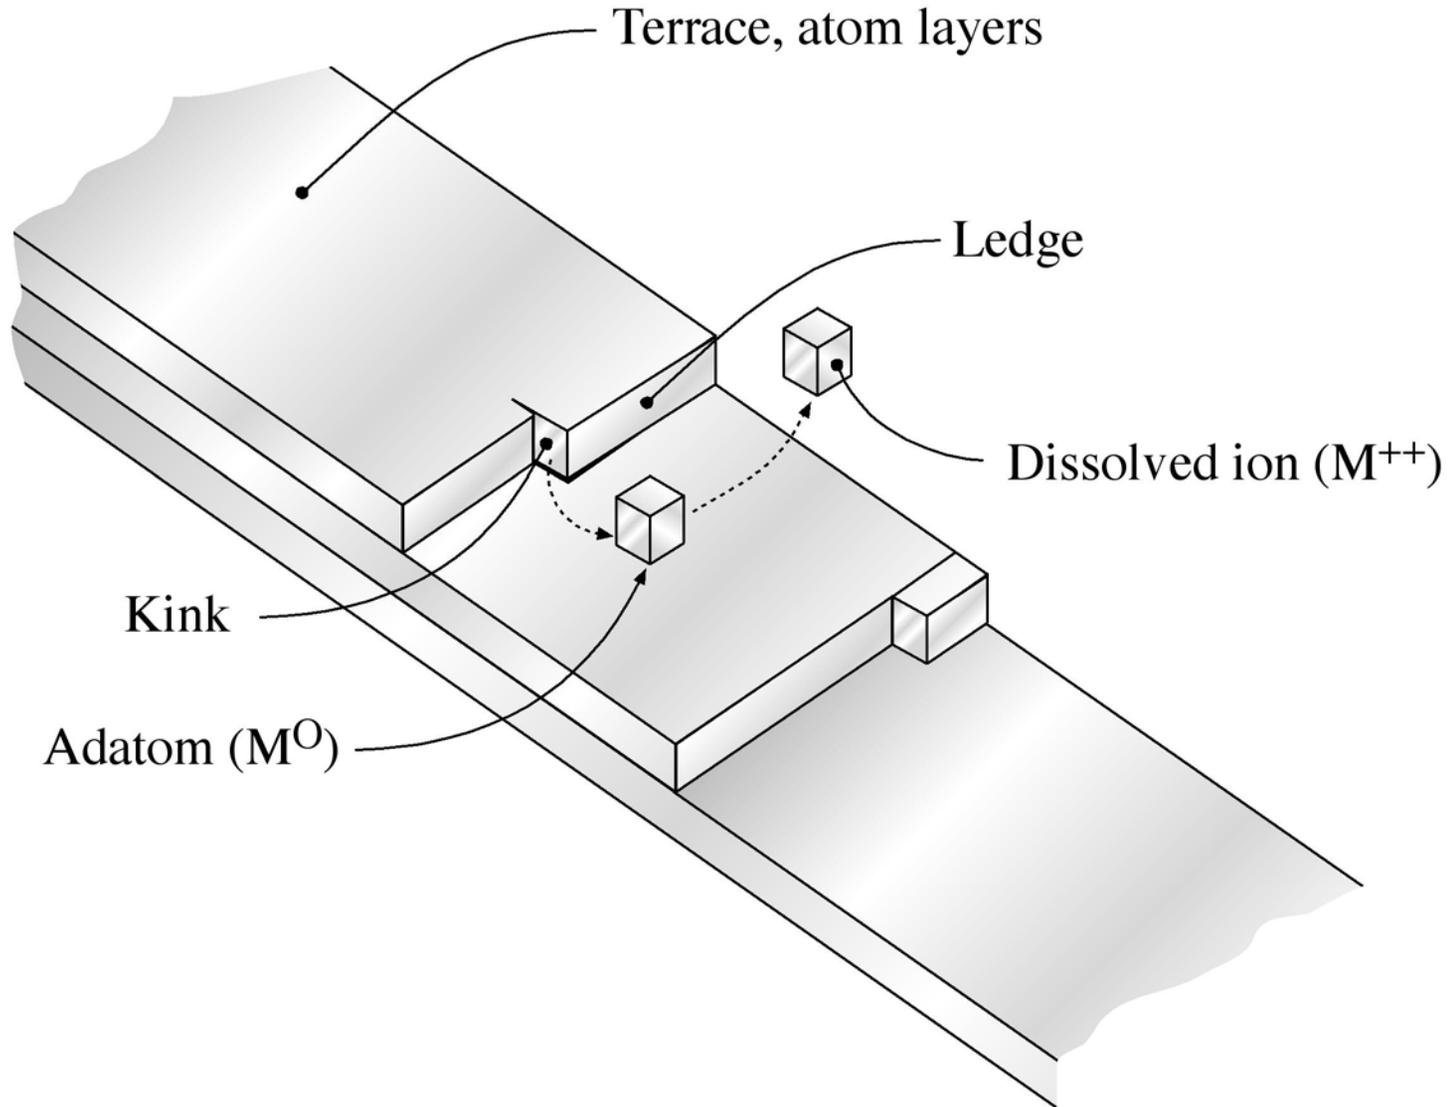
Terrace-Ledge-Kink (TLK) Dissolution

1. Terrace-ledge-kink TLK

- Indicates that dissolution is occurring without significant passive film.
- High rates occur when no inhibitive species to block kink sites.

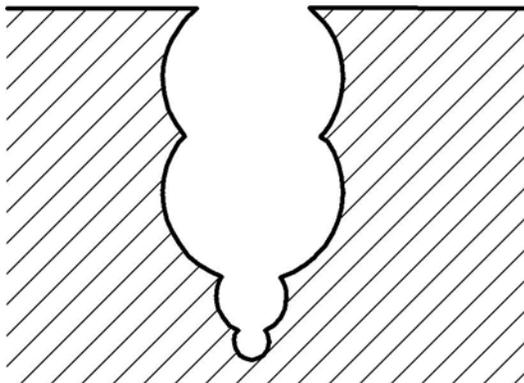
Continuous Growth by Re-nucleation (Non-structural)

Initial

Re-nucleates at bottom

Process of re-nucleation and
growth continues and does
not stop

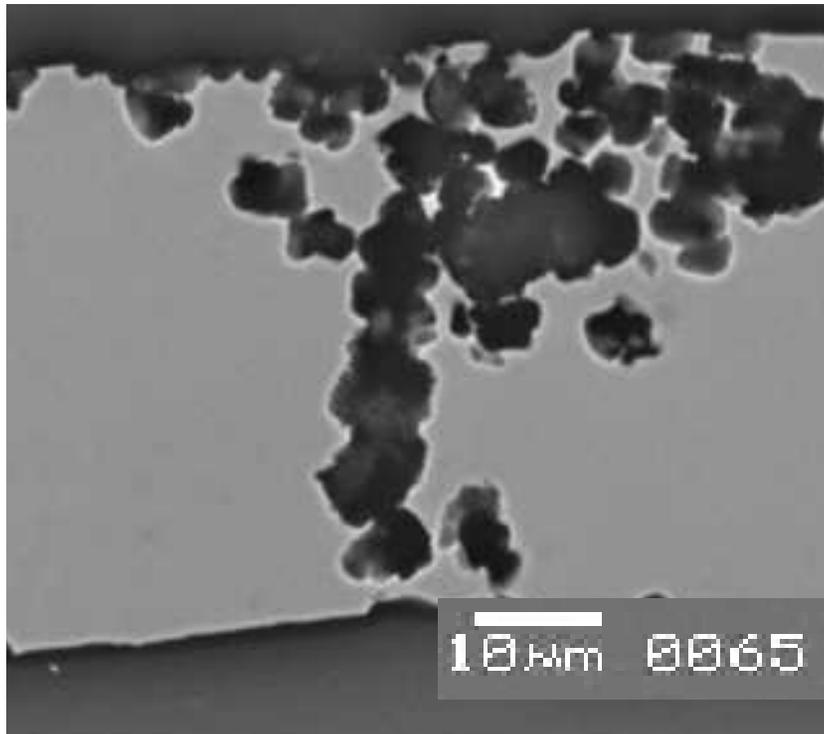
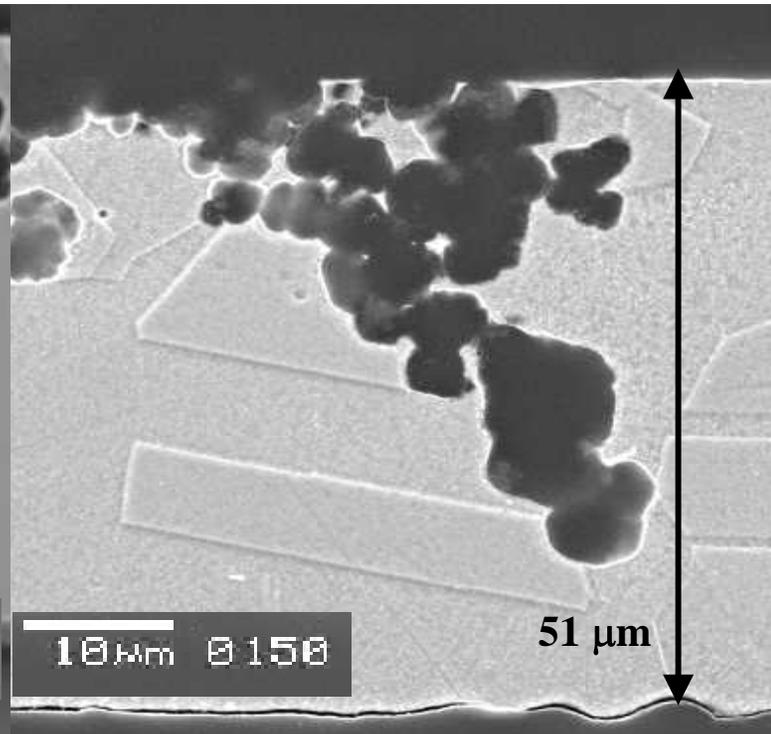
Initially, 1243x UZ pore water (F 15)

- Paste environment, bottom of flask
- 150°C
- Specimen of C-22: 76.2x12.7x 0.051 mm
- <5 days test
- >3.7mm/year penetration rate

1243x UZ foil paste 150°C,
>3.7 mm/yr (109)

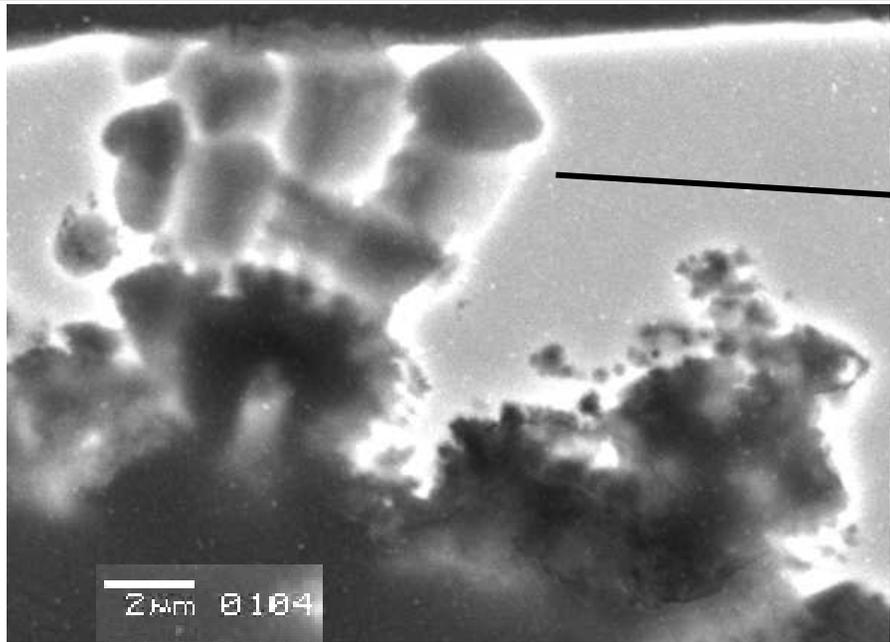
Initially 1243x UZ pore water (F 15)

- Paste environment, bottom of flask
- 150°C
- Specimen of C-22: 76.2x12.7x 0.051 mm
- <5 days test
- >3.7mm/year (0.15 in/year) penetration rate

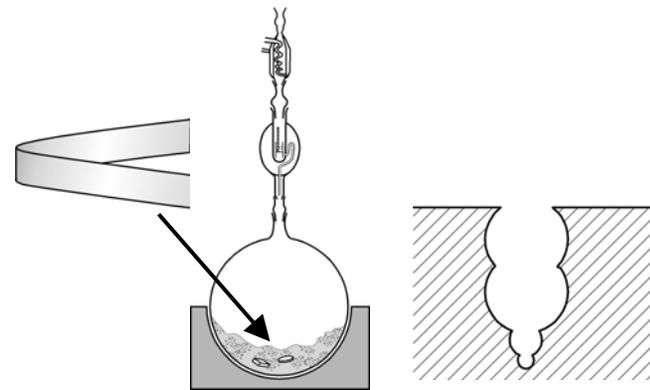
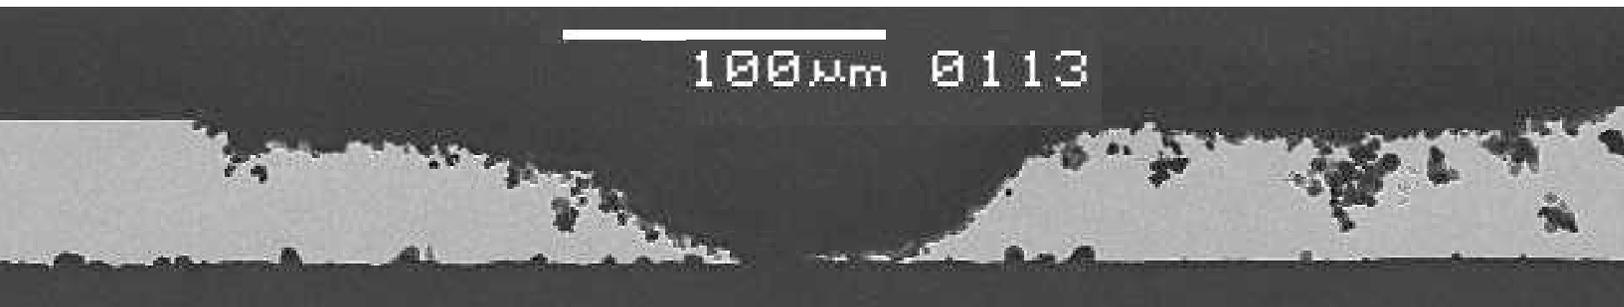
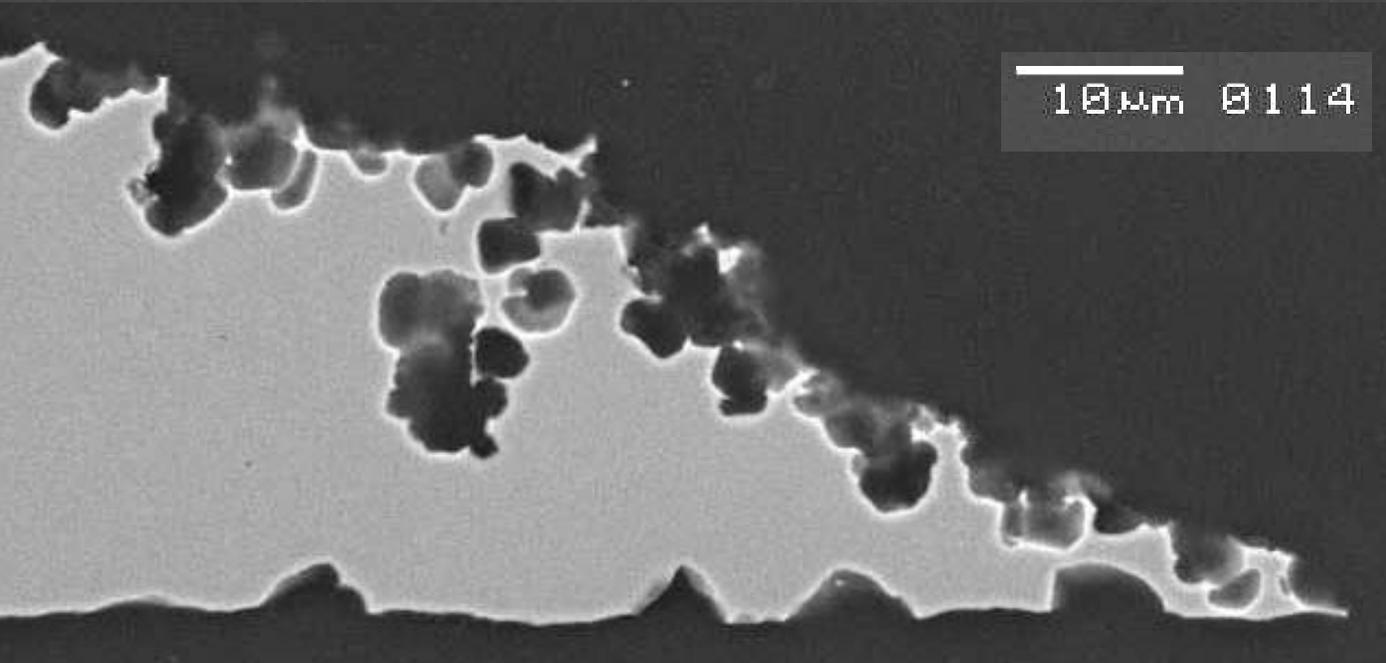
Initially 1243x UZ pore water (F 15)

- Paste environment, bottom of flask
- 150°C
- Specimen of C-22: 76.2x12.7x 0.051 mm
- <5 days test
- >3.7mm/year (0.15 in/year)penetration rate

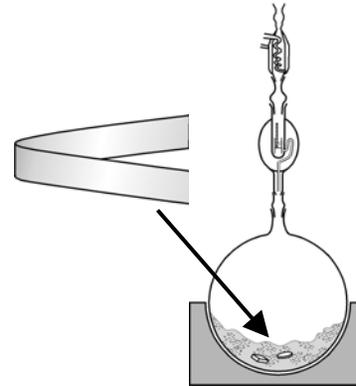
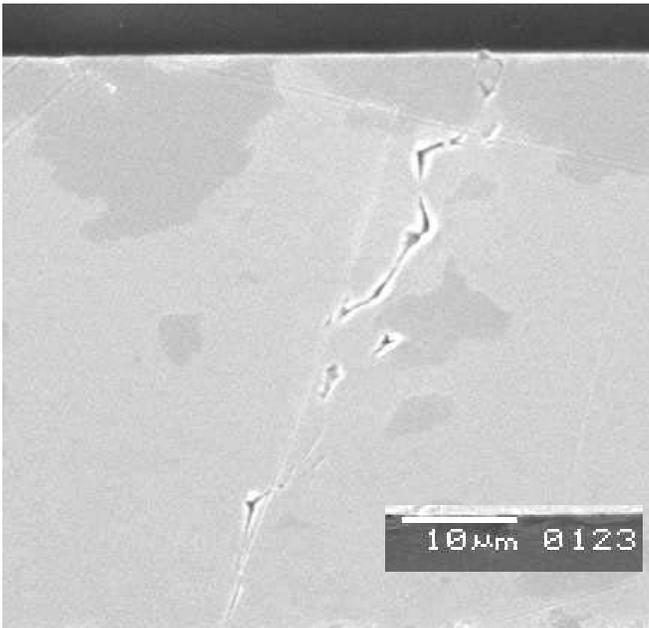
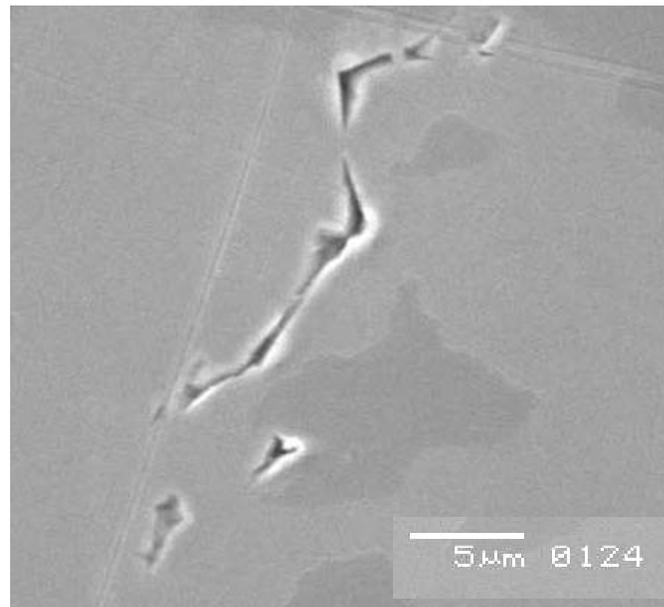
Initially 1x UZ pore water (F 14)

- Paste environment, bottom of flask
- 120°C
- Specimen of C-22: 76.2x12.7x 0.051 mm
- 8 days
- Minimal general corrosion, one SCC observed.

1x UZ, 120°C (123)

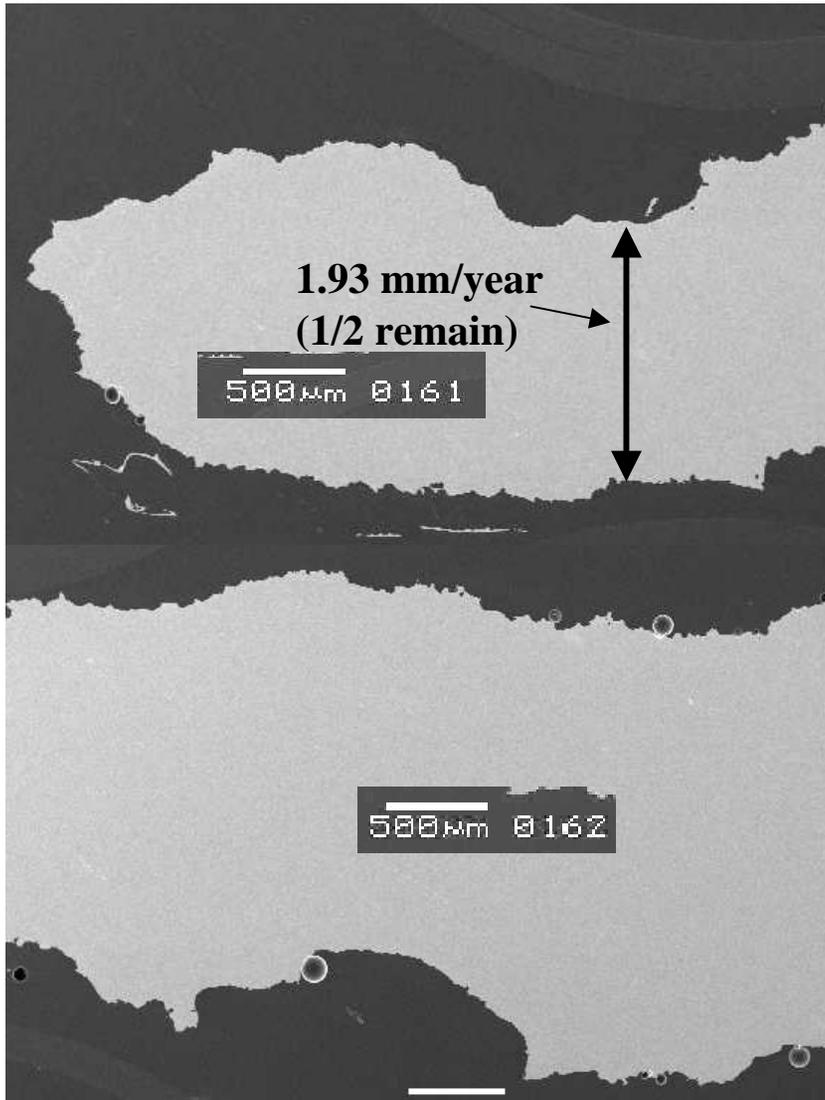
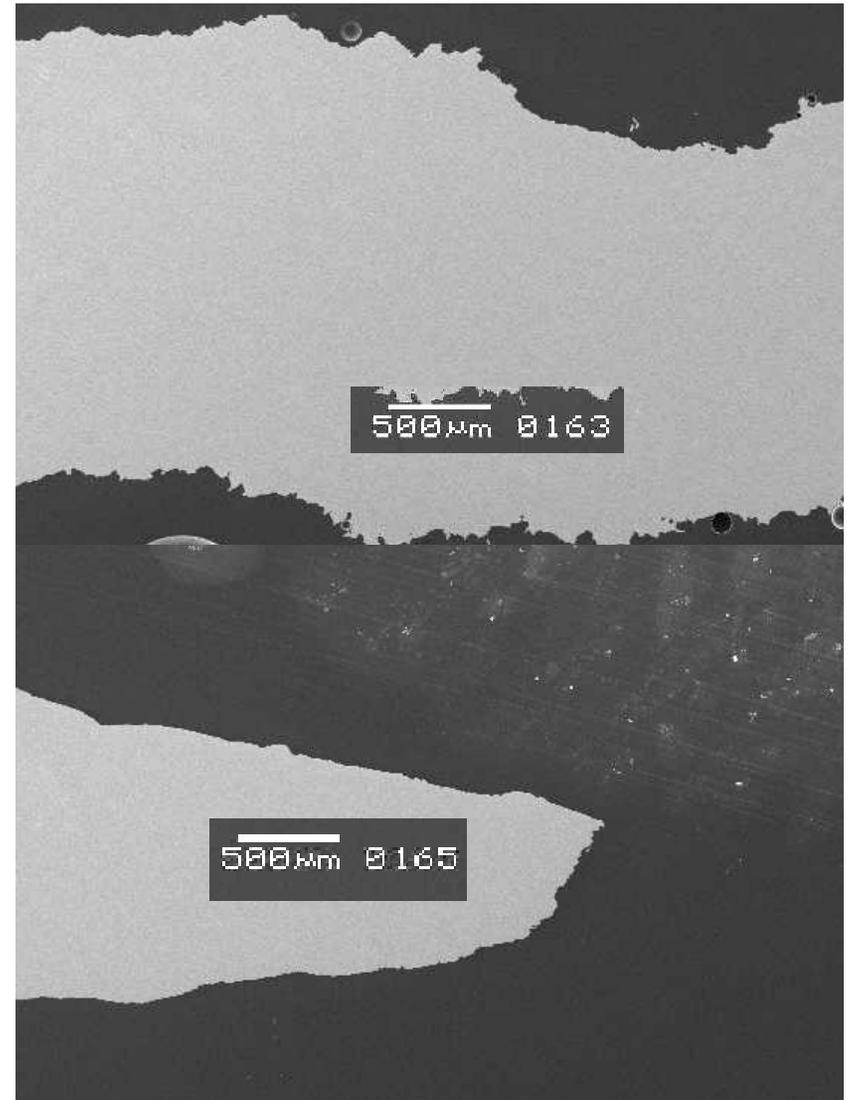
Initially 1243xUZ pore water (α -22 disc)

- Paste environment, bottom of flask
- 145°C
- Specimen of C-22: 2.54 diam x 3.18 mm
- Six months test: 1.93 mm/yr

1243x UZ disc, 145°C,
1.9 mm/yr (161)

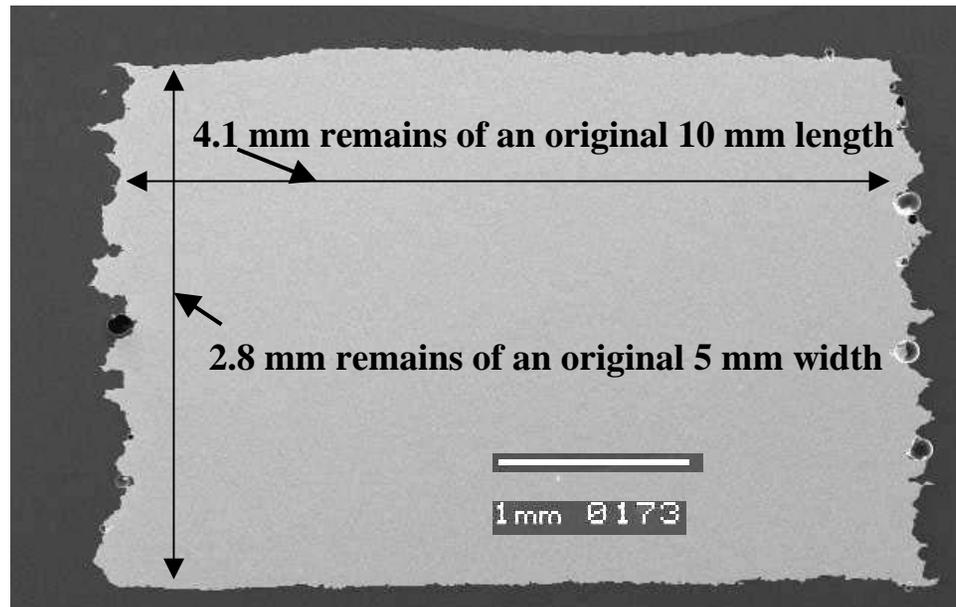
Initially 1243x UZ pore water(α -22 Soxhlet)

- Specimen completely immersed in Soxhlet, pH 0.53
- 75°C
- Specimen of C-22: 10 x 5 x 3.18 mm
- Six months test
- 5.5 mm/yr penetration (one side)

1243x UZ sox 75°C,
5.5m/yr (178)

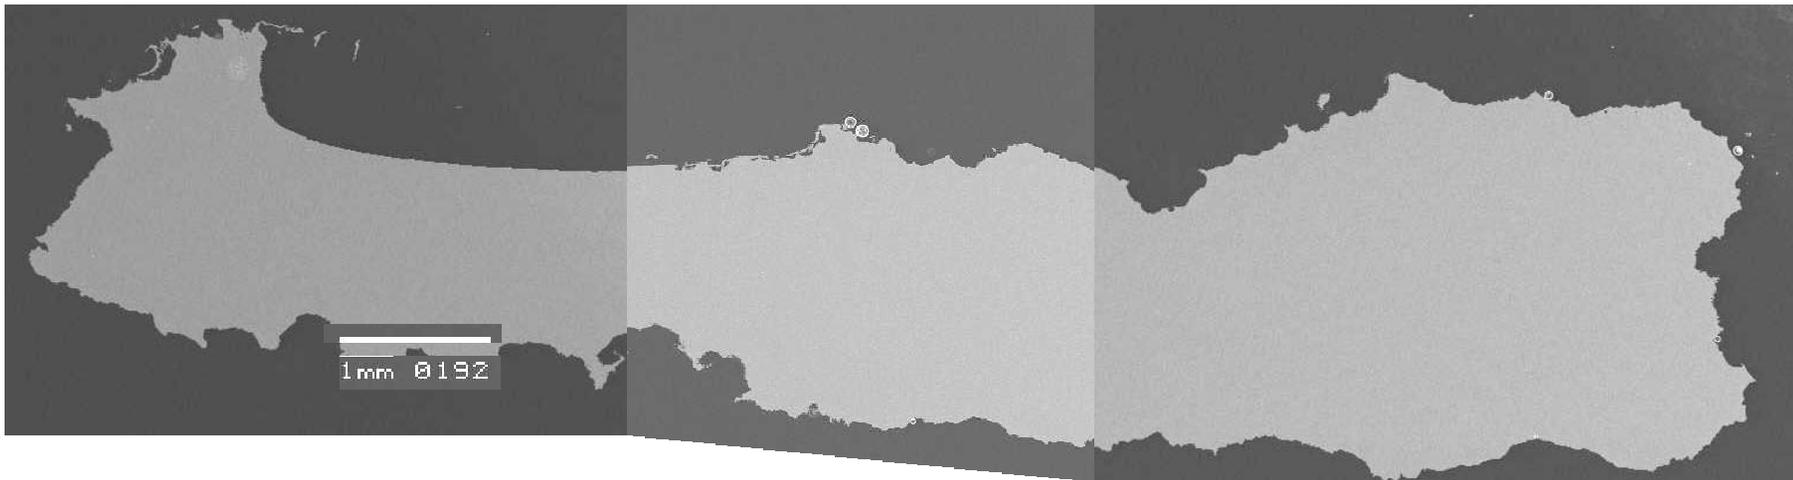
Initially 1243x UZ pore water (α -22 U-bend)

- Specimen immersed in paste
- 145°C
- Specimen of C-22: 55 x 13 x 3.18 mm (around 6.35 mm mandrill)
- Six months test
- 2.1 mm/yr penetration (one side)

1243x UZ U bend,
145°C, **2.1 mm/yr (202)**

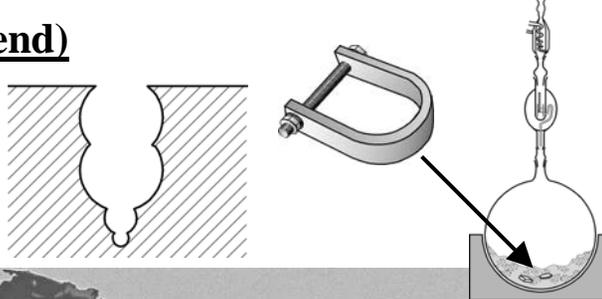
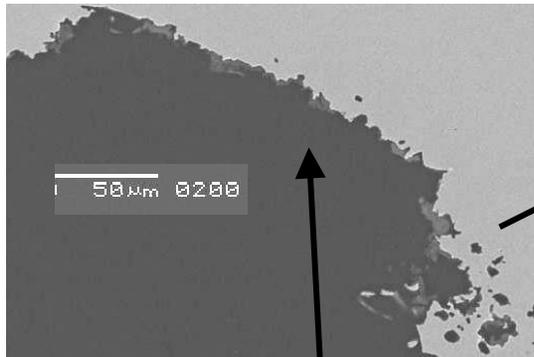
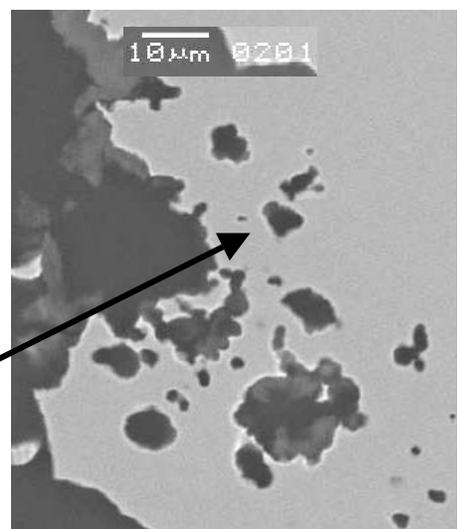
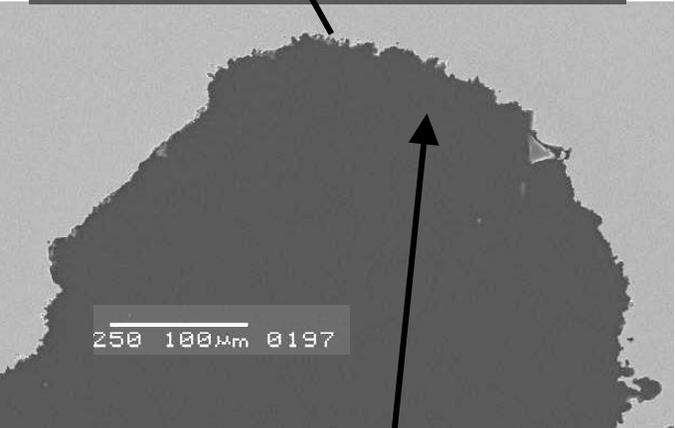
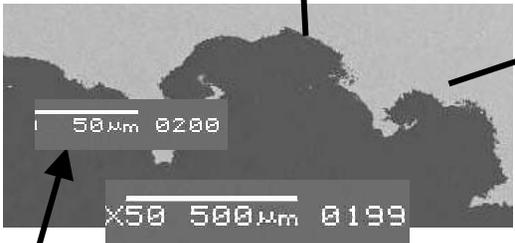
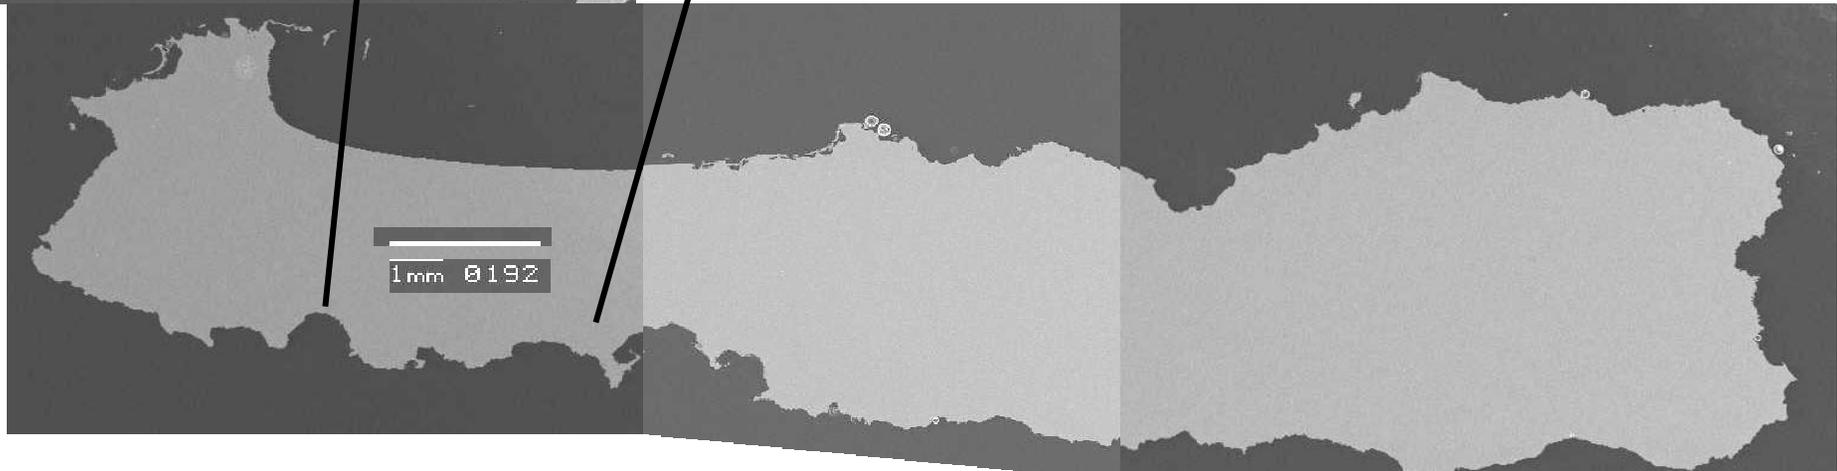
Initially 1243x UZ pore water (α -22 U-bend)

- Specimen immersed in paste
- 145°C
- Specimen of C-22: 55 x 13 x 3.18 mm
- Six months test
- 2.1 mm/yr penetration (one side)

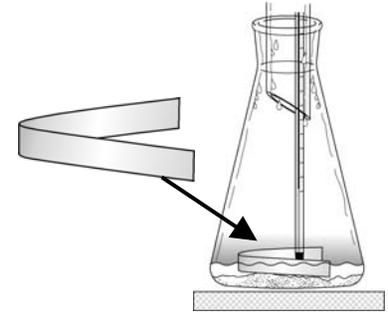
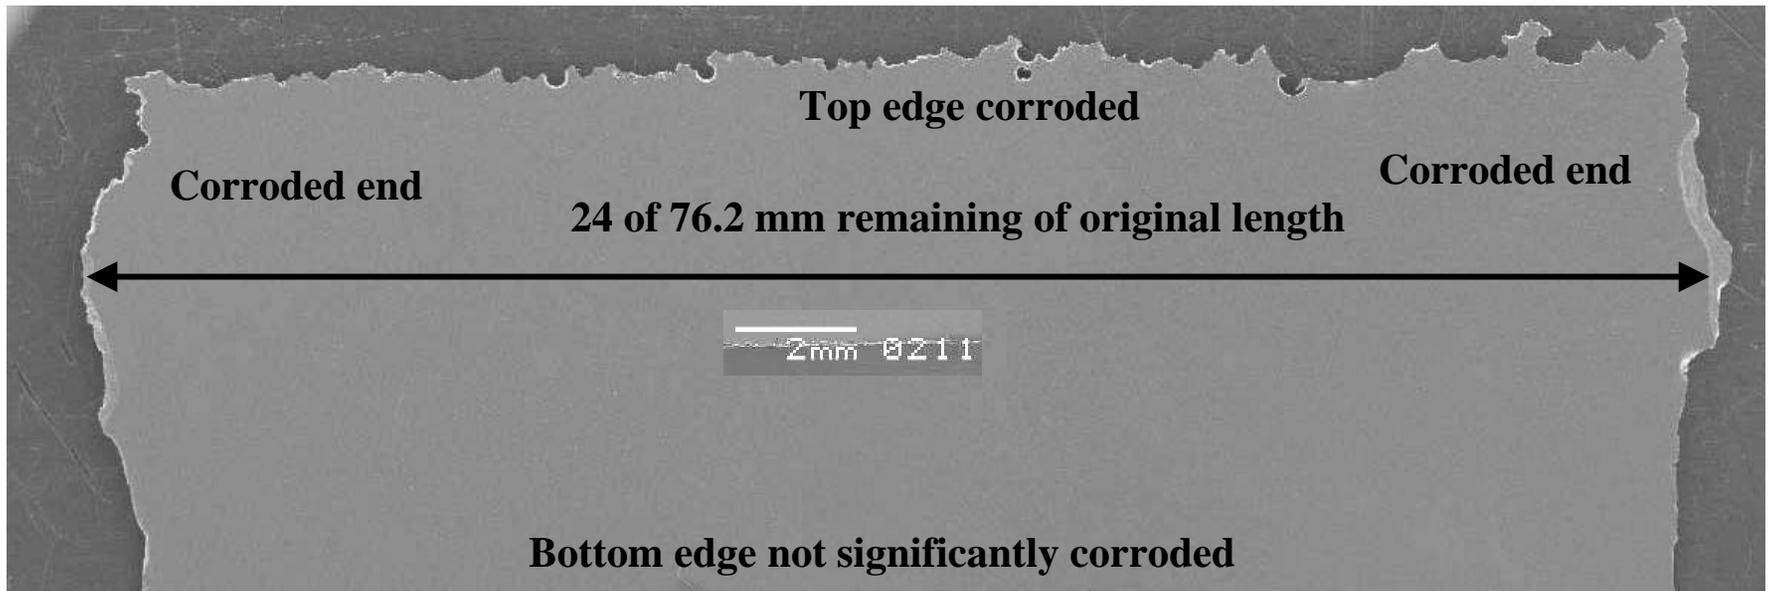
Saturated FeCl₃, Erlenmeyer (F 59)

- C-22 specimen on edge and half submerged
- 128°C
- Six days; extensive corrosion in last 3 1/2 hours, lost both ends
- 76.2 x 12.7 x 0.051 mm
- Rate: >1.6 mm/year(one side)

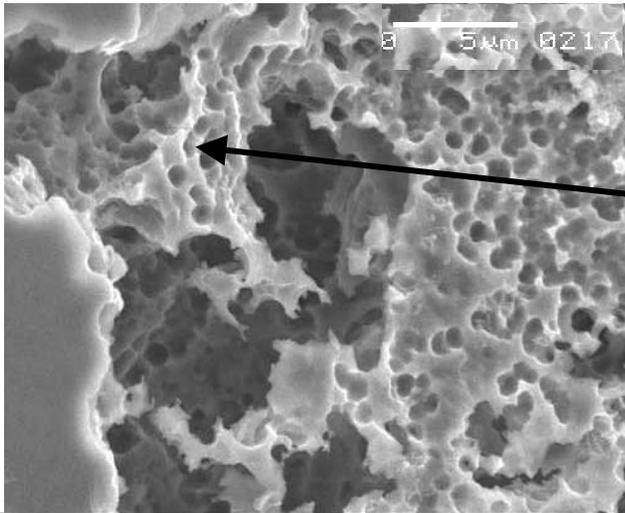
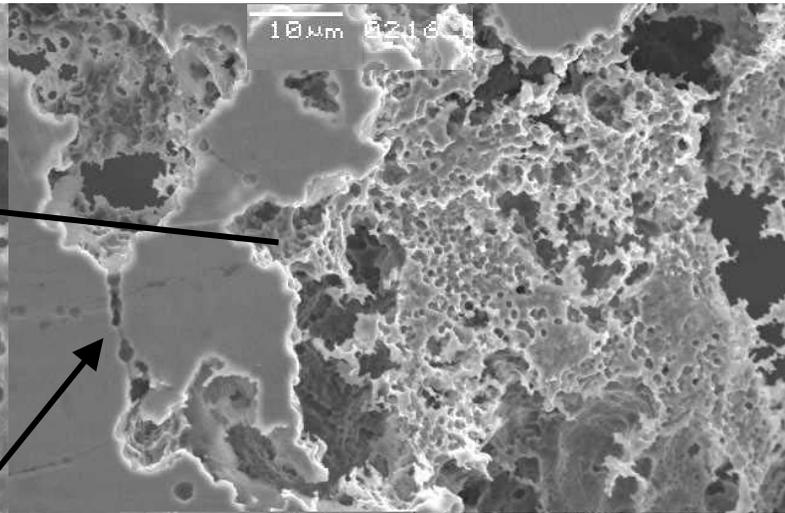
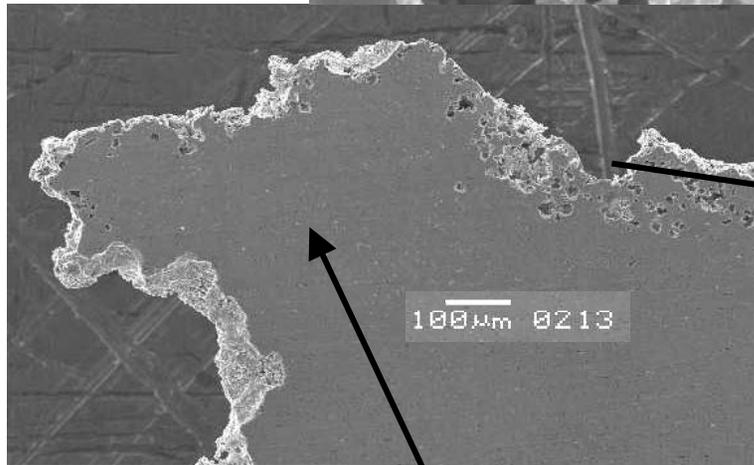
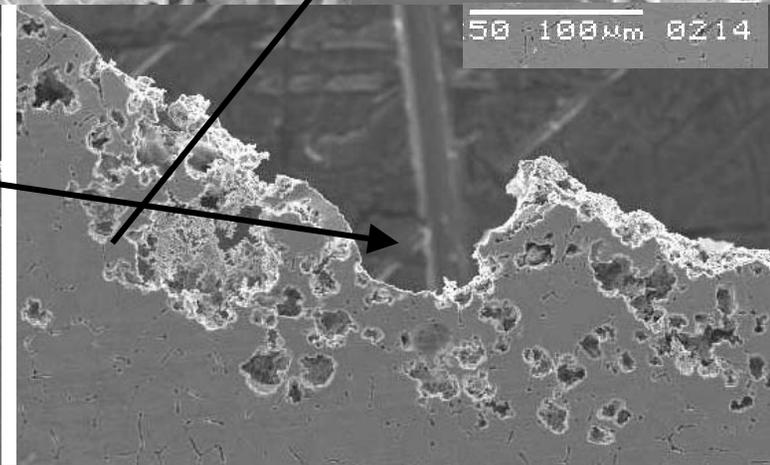
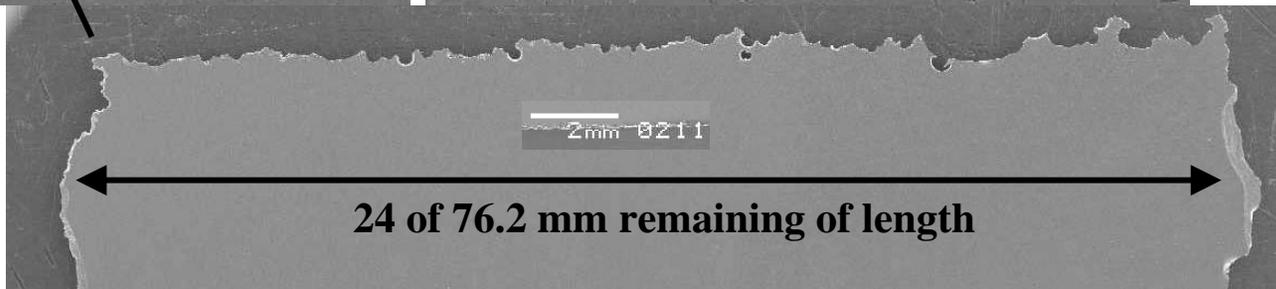
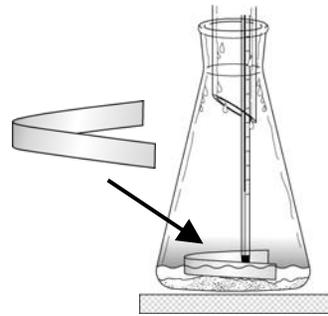
Saturated FeCl₃, Erlenmeyer (F 59)

- C-22 specimen on edge and half submerged
- 128°C six days, extensive corrosion in last 3 1/2 hours, lost both ends
- Rate:
> 1.6 mm/year

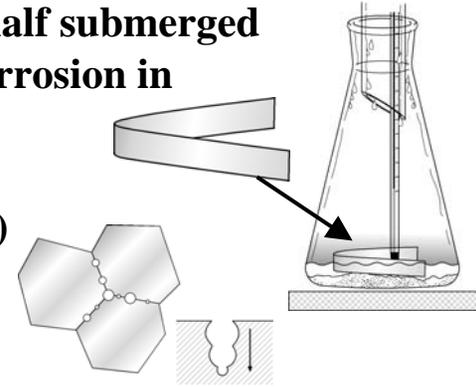
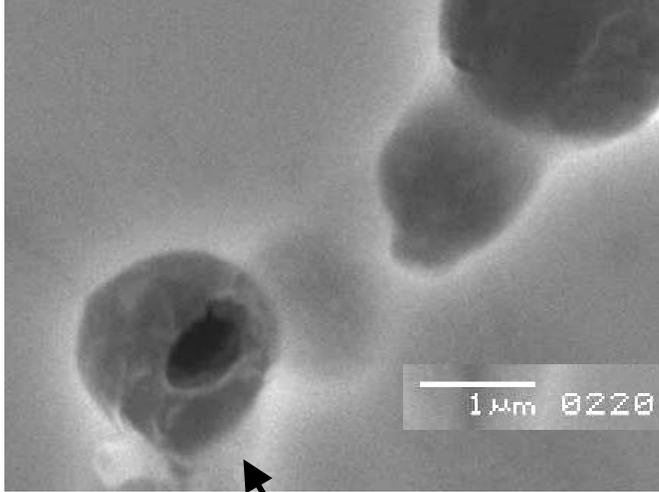
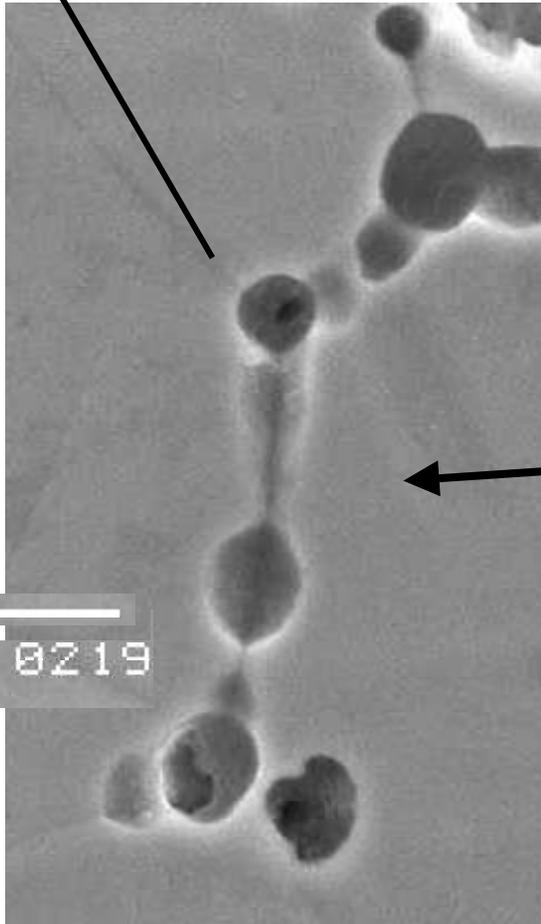
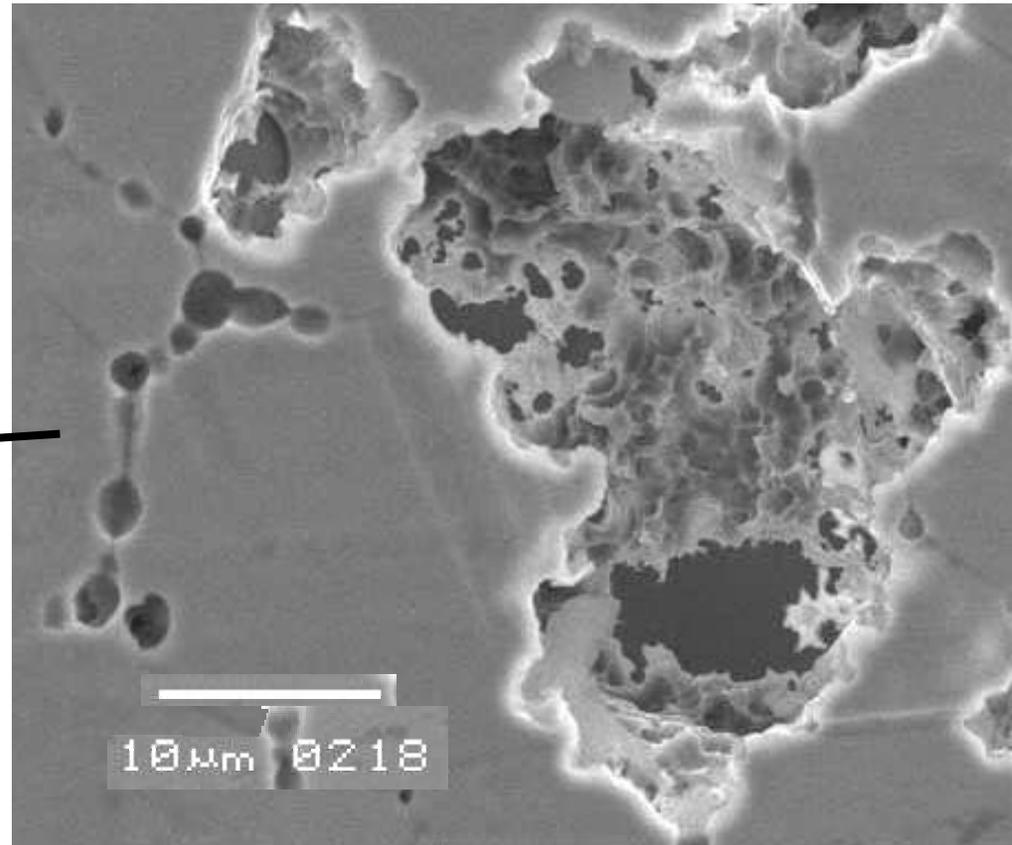
Saturated FeCl₃, Erlenmeyer (F 59)

- C-22 specimen on edge and half submerged
- 128°C; six days; extensive corrosion in last 3.5 hours, lost both ends
- 76.2 x 12.7 x 0.051 mm
- Rate: >1.6 mm/year(one side)

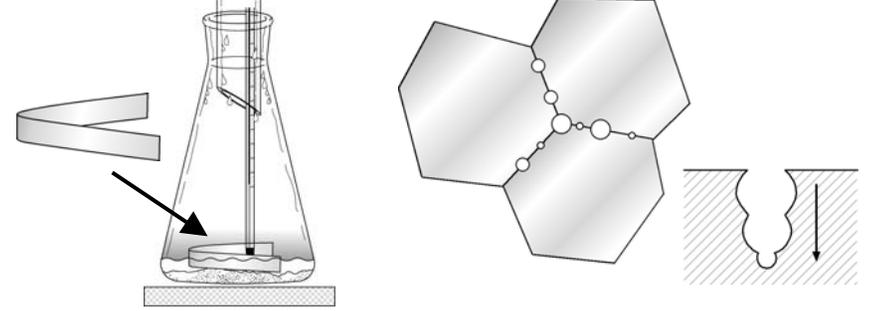
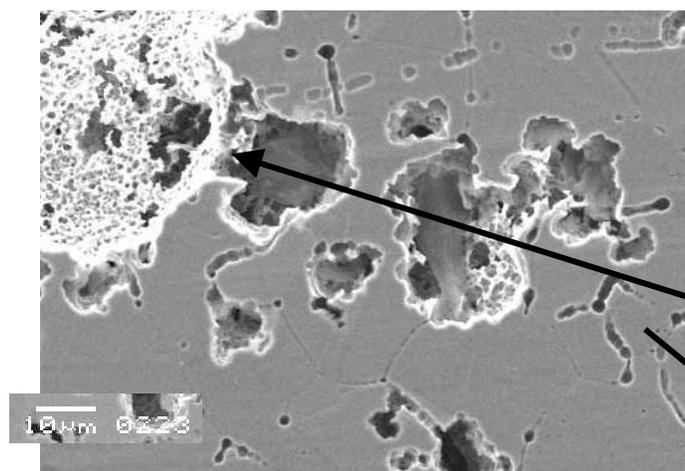
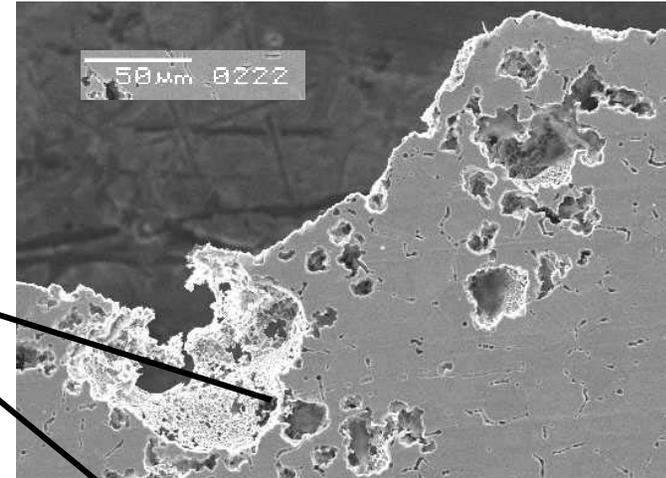
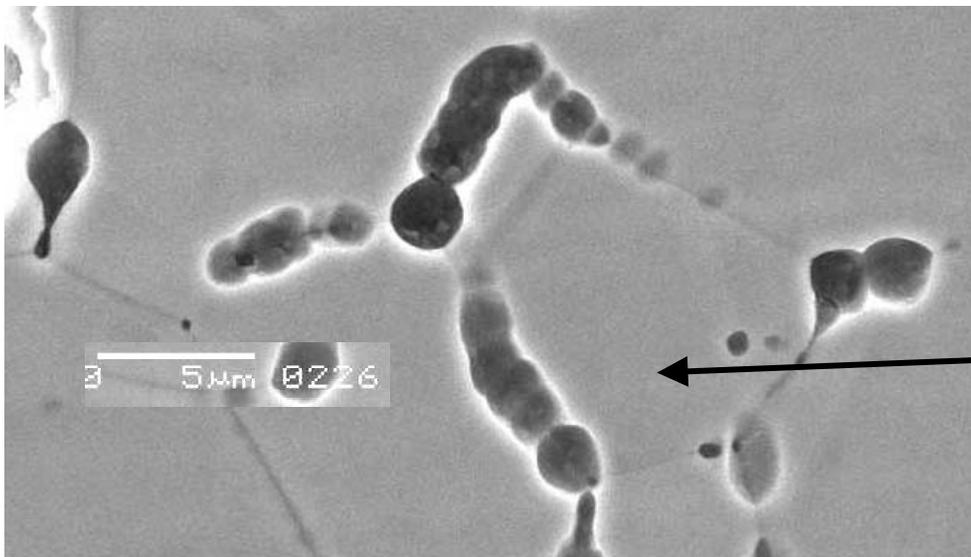
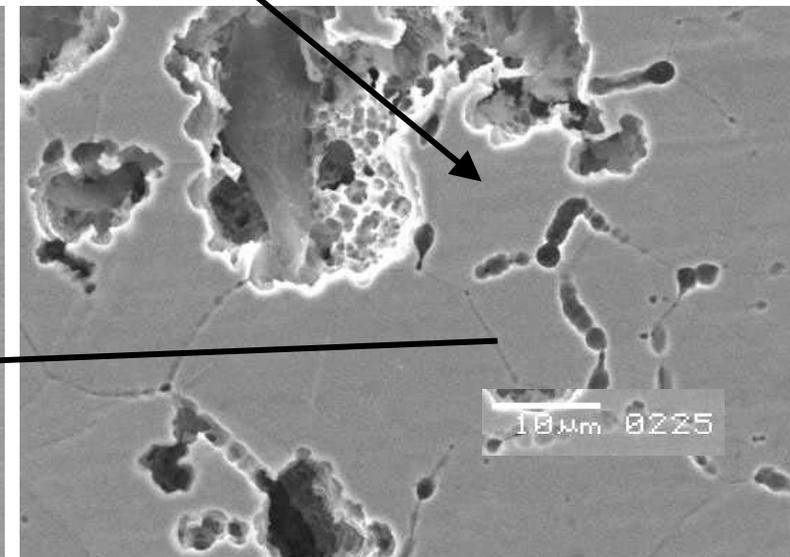
Saturated FeCl₃, Erlenmeyer (F 59)

- C-22 specimen on edge and half submerged
- 128°C
- Six days; extensive corrosion in last 3 1/2 hours, lost both ends
- 76.2 x 12.7 x 0.051 mm
- Rate: >1.6 mm/year (one side)

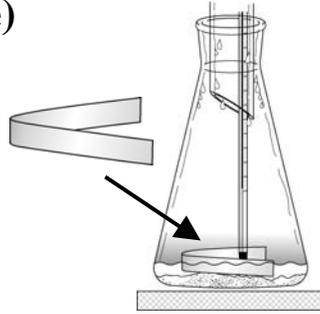
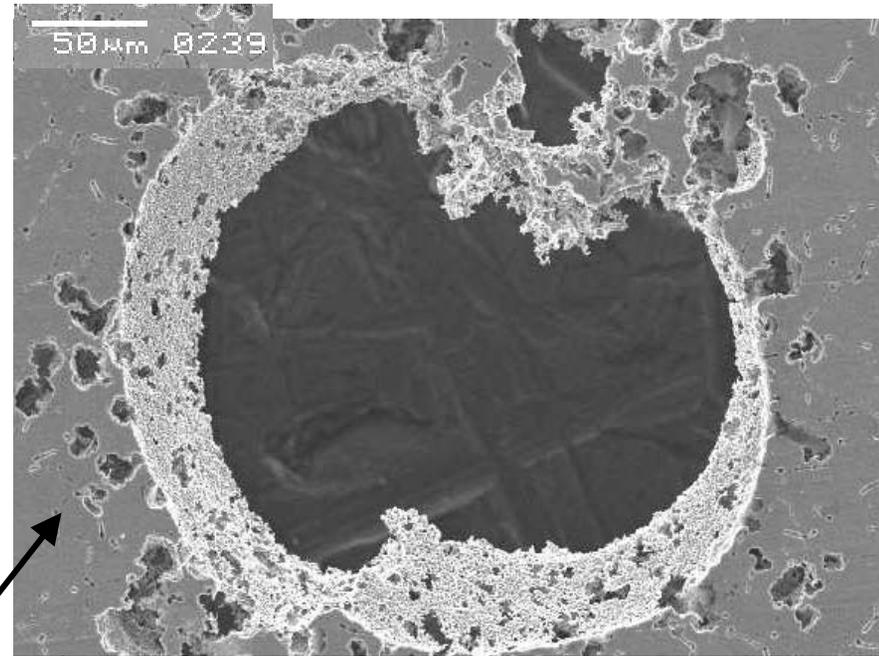
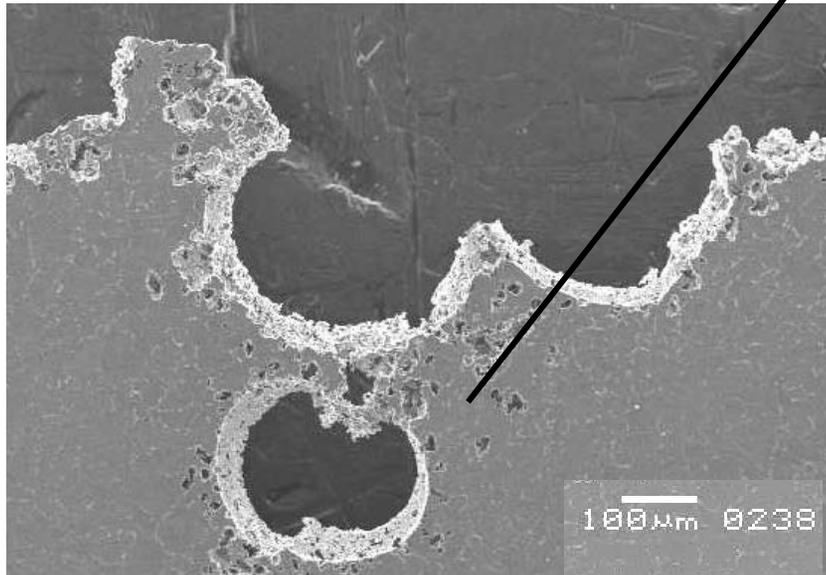
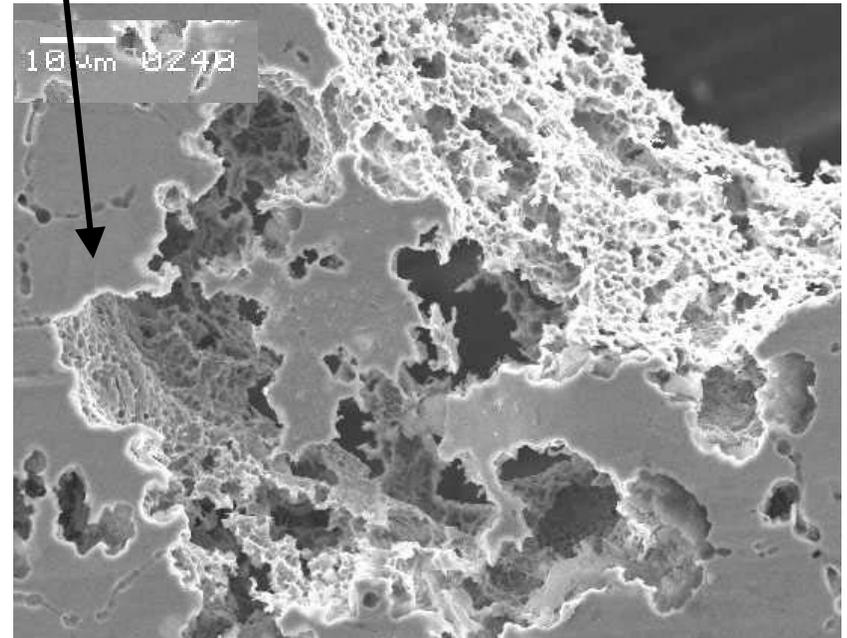
Saturated FeCl₃, Erlenmeyer (F 59)

- C-22 specimen on edge and half submerged
- 128°C
- Six days; extensive corrosion in last 3.5 hours, lost both ends
- 76.2 x 12.7 x 0.051 mm
- Rate: >1.6 mm/year(one side)
