Bases for Predicting Occurrences of Rapid Corrosion on the Surfaces of Containers of C-22 at Yucca Mountain

**Presented at the Spring Meeting
of the NWTRB at Embassy Suites Hotel
Washington, D.C.
May 18, 19, 2004**

**by Dr. Roger W. Staehle
On behalf of the State of Nevada**

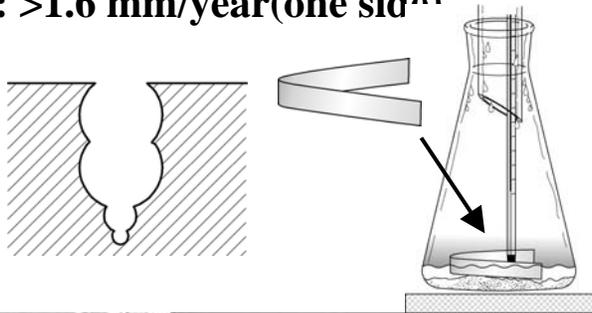
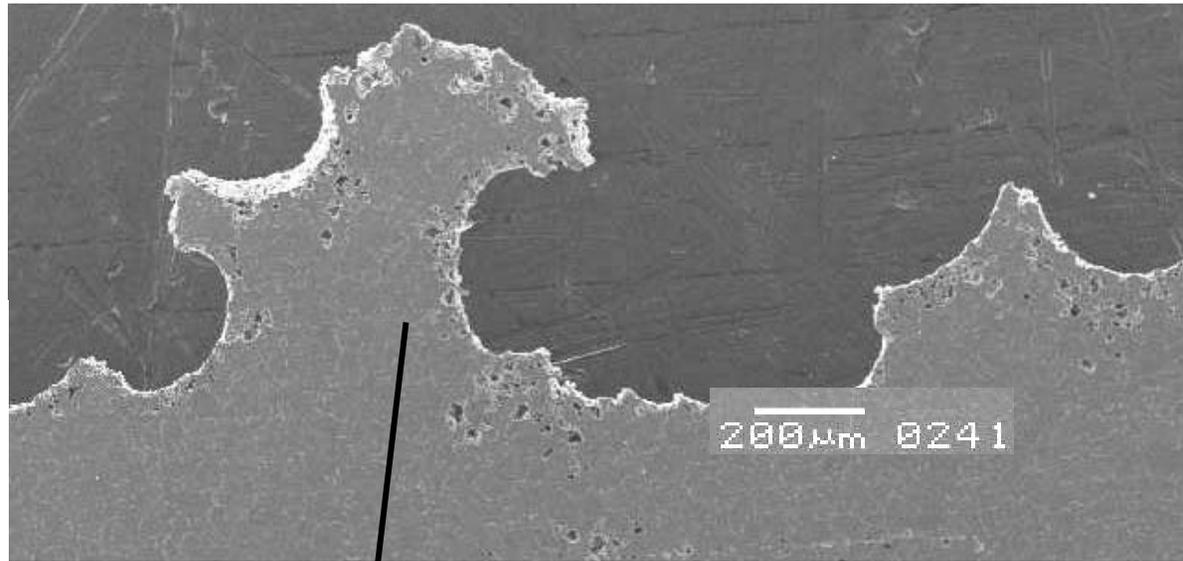
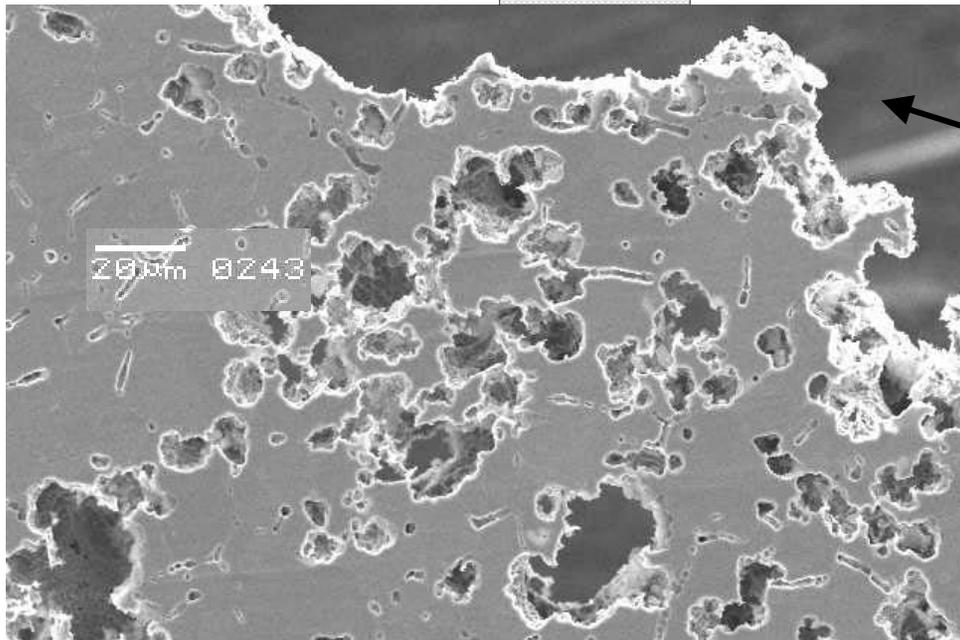
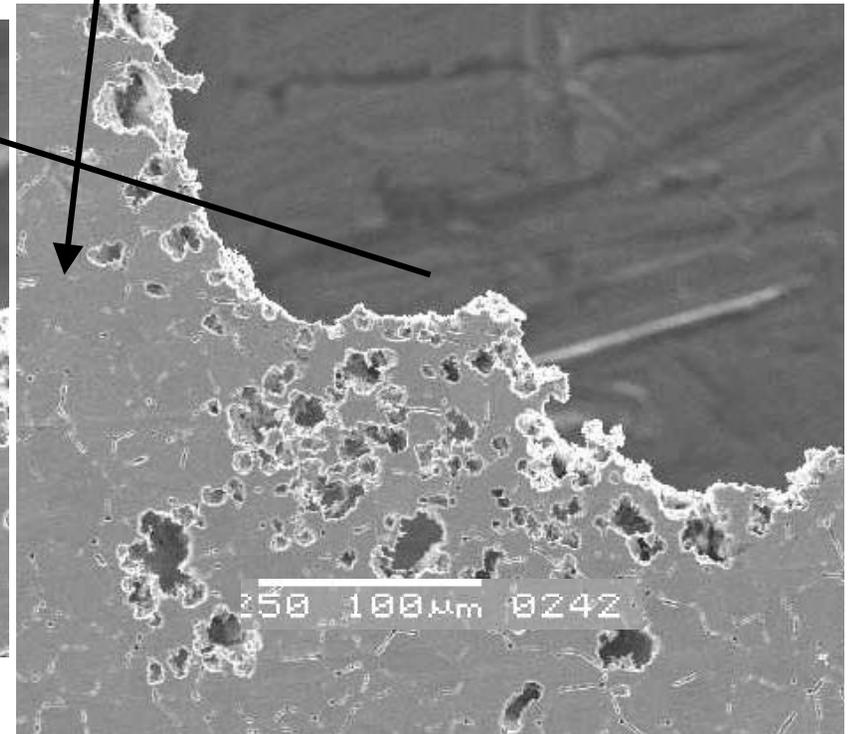
Saturated FeCl₃, Erlenmeyer (F 59)

- C-22 specimen on edge and half submerged
- 128°C
- Six days; extensive corrosion in last 3.5 hours, lost both ends
- 76.2 x 12.7 x 0.051 mm
- Rate: >1.6 mm/year(one side)

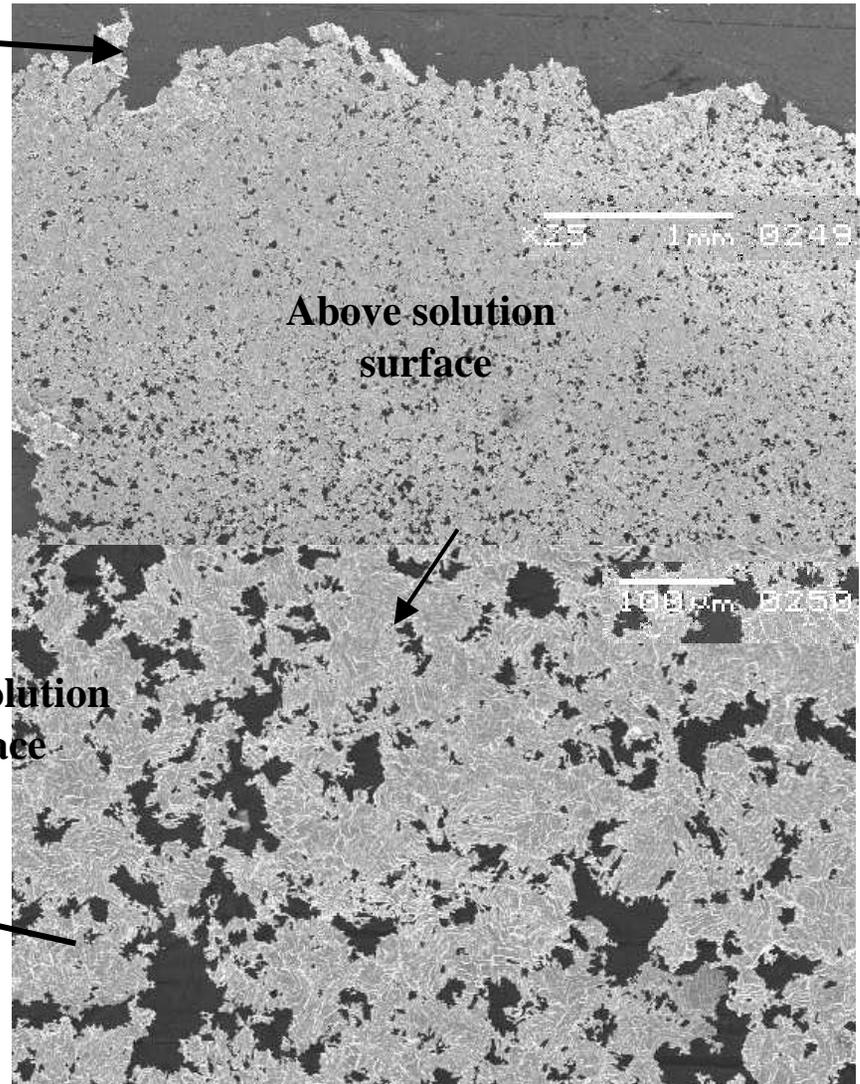
Boiling Conc. HCl, Erlenmeyer (F 62)

- C-22 specimen on edge and half submerged
- 110°C, • 42 hours
- U bend • 76.2 x 12.7 x 0.051 mm
- Rate of top >5.32 mm/yr (one side)

Boil, conc HCl, 110°C,
2-6 mm/yr, (264)

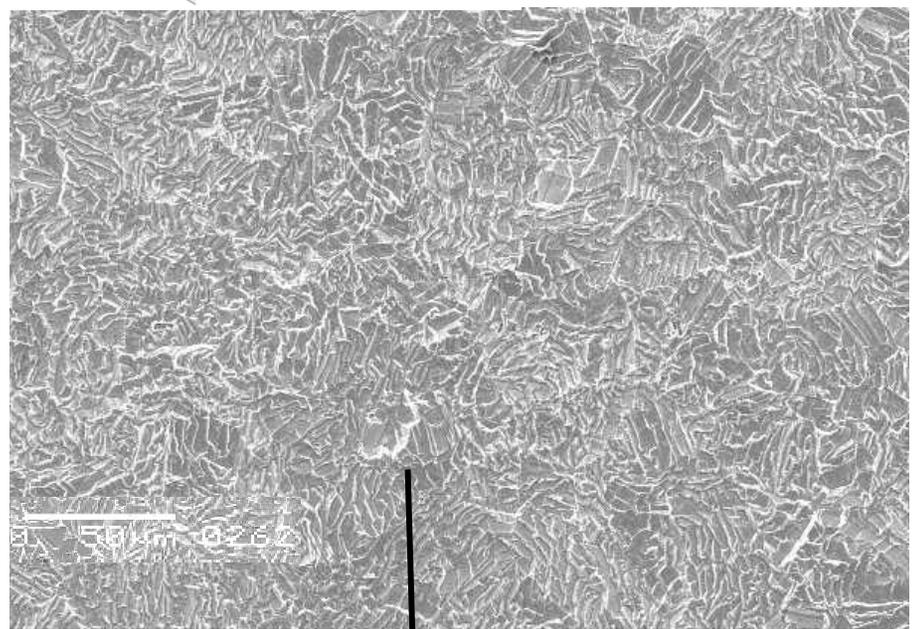
Boiling Conc HCl, Erlenmeyer (F 62 bottom)

- C-22 specimen on edge and half submerged
- 110°C, • 42 hours
- U bend, 76.2 x 12.7 x 0.051 mm
- Rate of bottom:
> 2.0 mm/yr (one side)

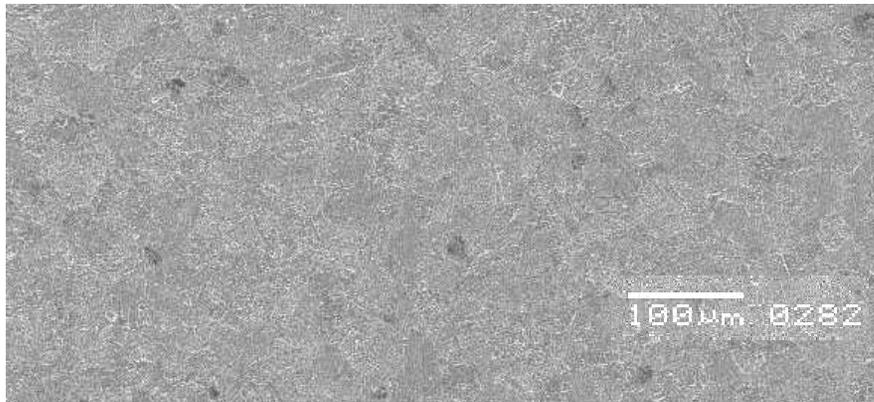
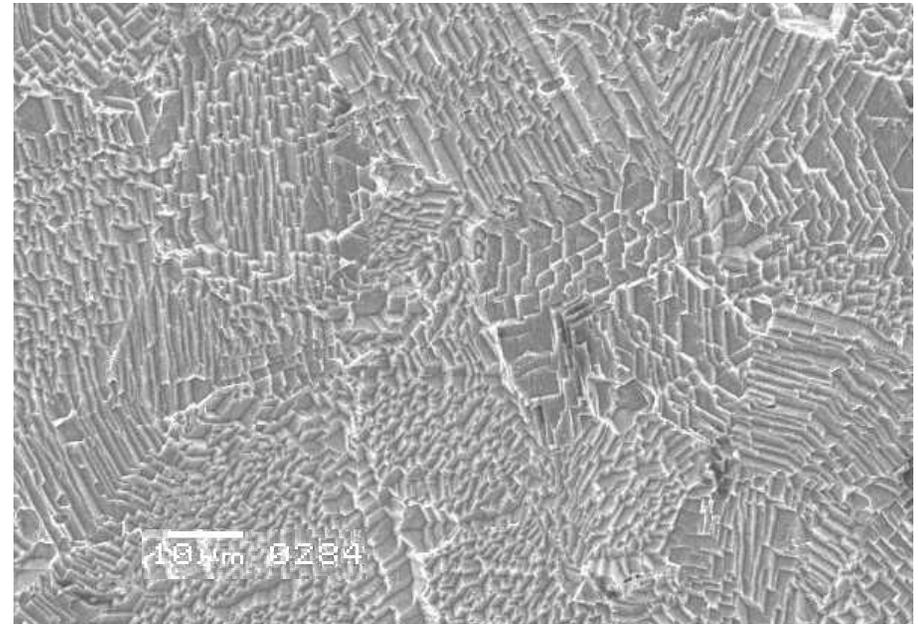
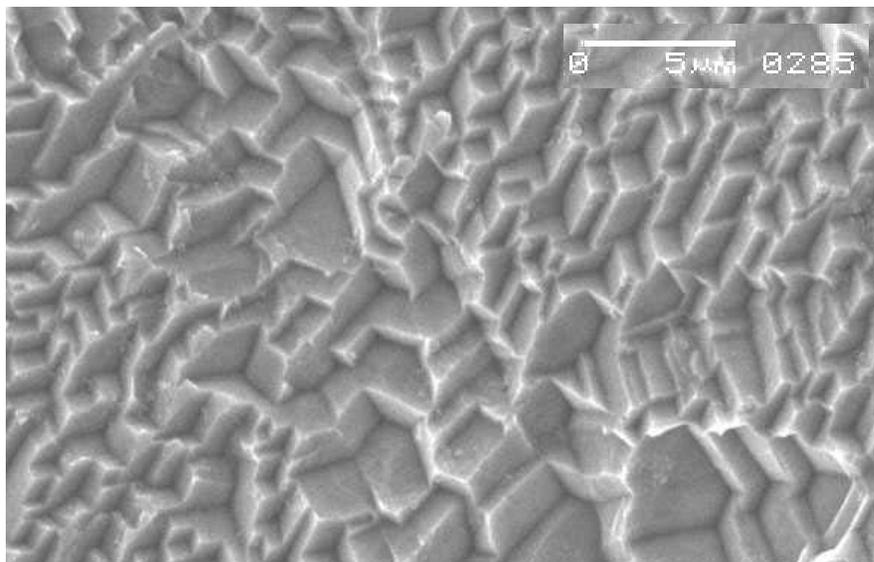
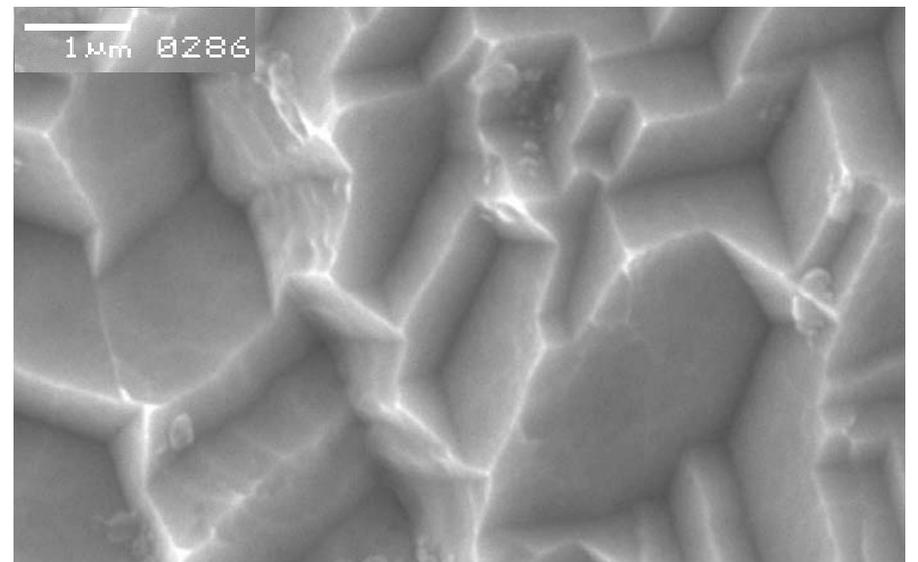
Boiling Conc HCl, Erlenmeyer (F 61 fully immersed)

- C-22 specimen fully immersed
- 110°C, 42 hours
- U bend, 76.2 x 12.7 x 0.051 mm

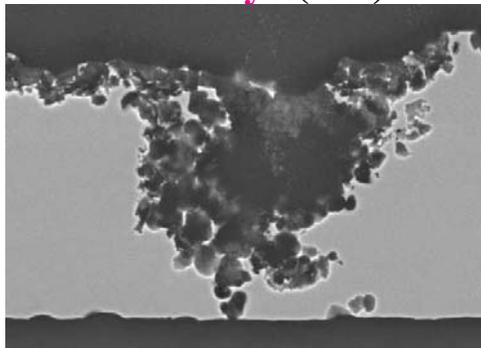
Summary of modes and rates of corrosion

1243x UZ foil paste 150°C,
>3.7 mm/yr (109)

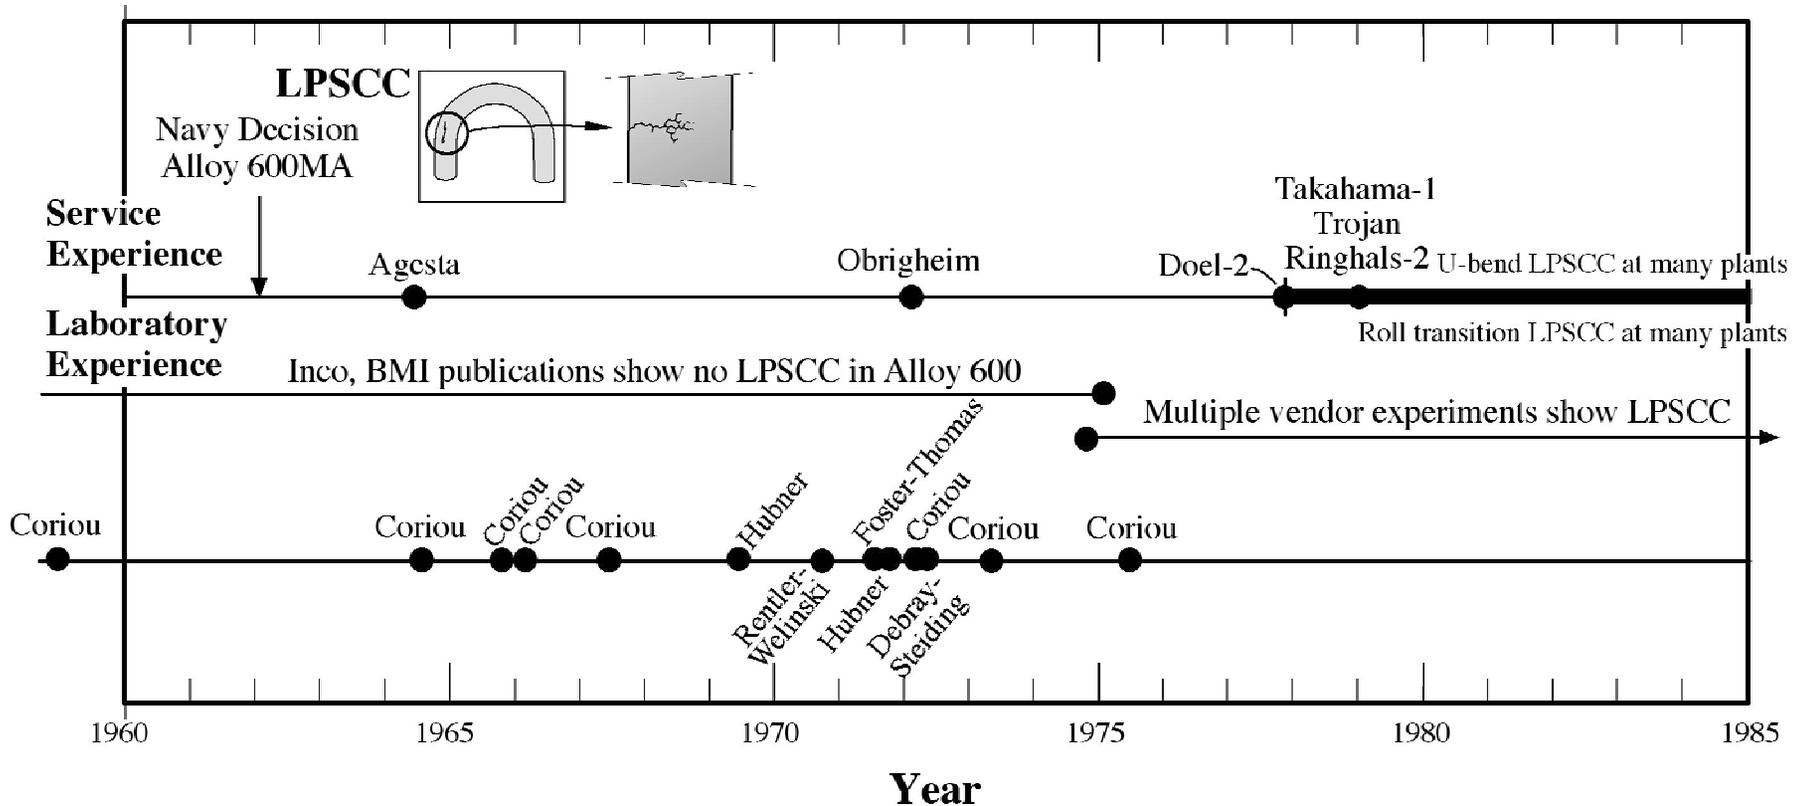
Chronology of LPSCC: service and laboratory experience

--Reticence to act on observations
