# Spent Nuclear Fuel Storage in L Basin

*Extended Storage Surveillance & Maintenance*

*Presentation to Nuclear Waste Technical Review Board  
October 29, 2014*

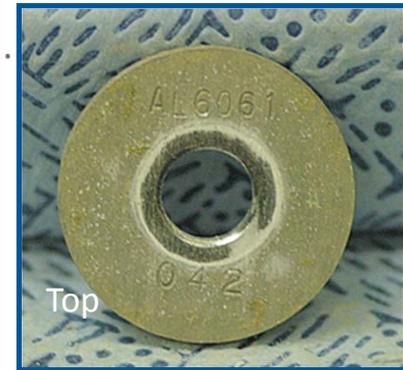
Research Reactor Fuel Corrosion Coupons

- Designed to include crevices and galvanic couples
- Pulled periodically for analysis by SRNL
- Results after 11 years in basin (Pulled May 2010)
  - *General corrosion rate – 0.03 mils per year*
  - *Crevice pits – average 2.5 mils deep*
  - *Galvanic corrosion pits – average 20 mils deep*
  - *More pitting on top surfaces; attributed to particulates*

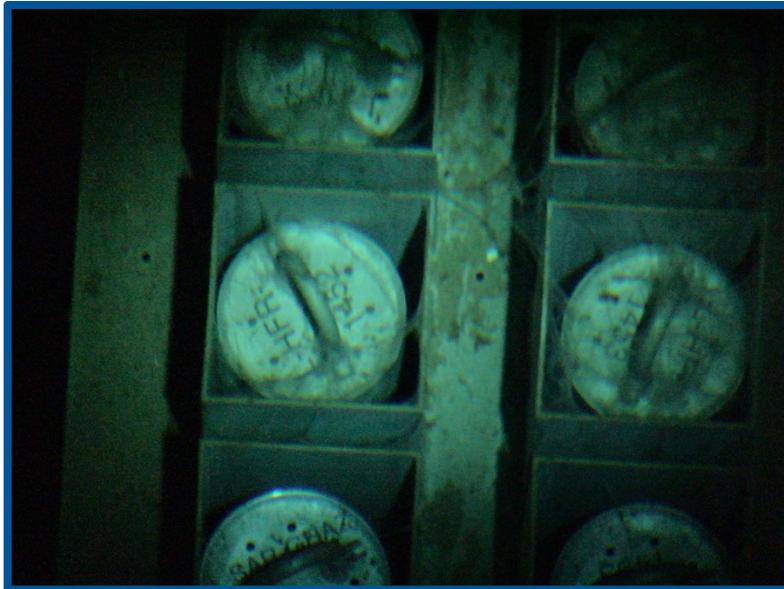
Before vacuuming

- Completed vacuuming of “cobwebs”
- Conduct periodic visual surveys for their return

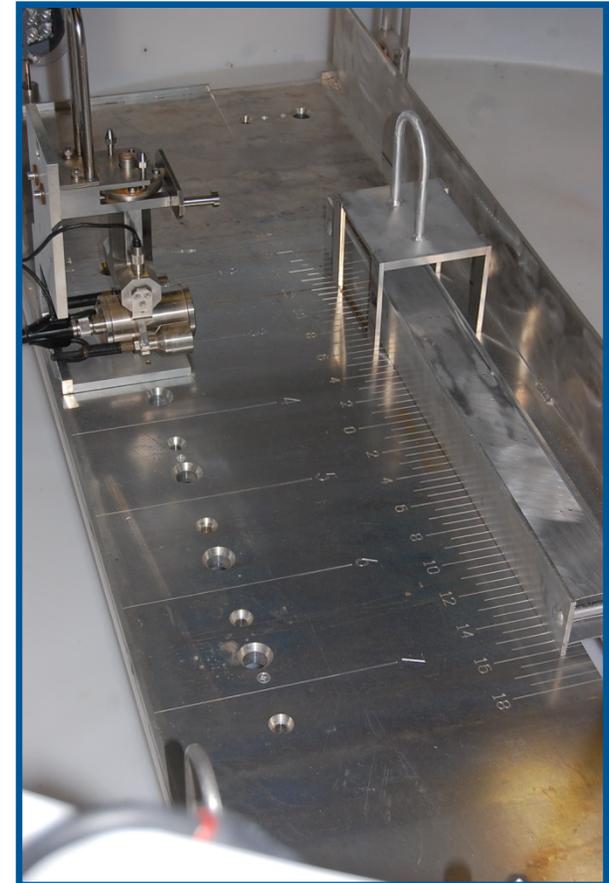
Fuel Inspection Table

- Establish in-service inspection program for bundled Material Test Reactor (MTR) fuel
  - Selection of fuels for inspection (complete)
    - *Fuels with known defects; various burnups; one with high cobweb density*
  - Develop inspection equipment & procedure (complete)
    - *Defined regions of interest for each assembly*
    - *Underwater cameras with reproducible geometry & lighting*
  - Sample water inside fuel bundle tubes before disturbing (complete; no anomalies)
    - *Conductivity, pH, alpha, beta/gamma, chlorides, metals, microbes*
  - Perform baseline visual inspections; evaluate results
  - Periodic reexamination; trend changes
