Post-Irradiation Examinations of High-Burnup PWR Fuel Rods—Initial Results

Rose Montgomery, Robert N. Morris,
Bruce Bevard, and John Scaglione

NWTRB Meeting
Albuquerque, NM
October 24, 2018

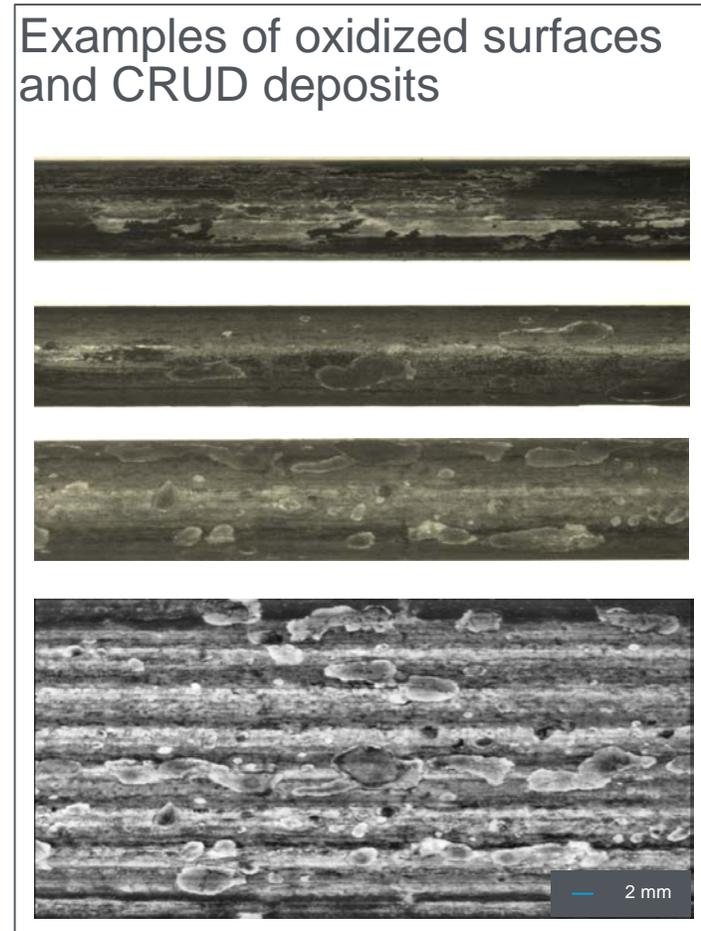
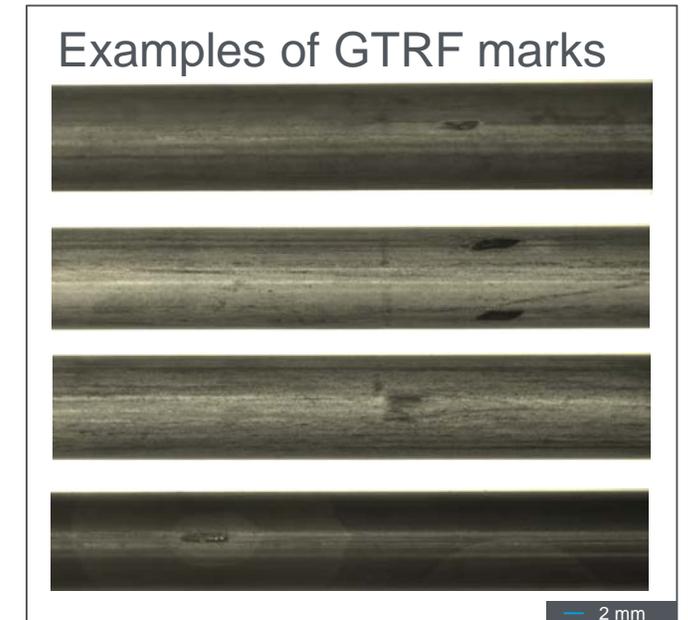
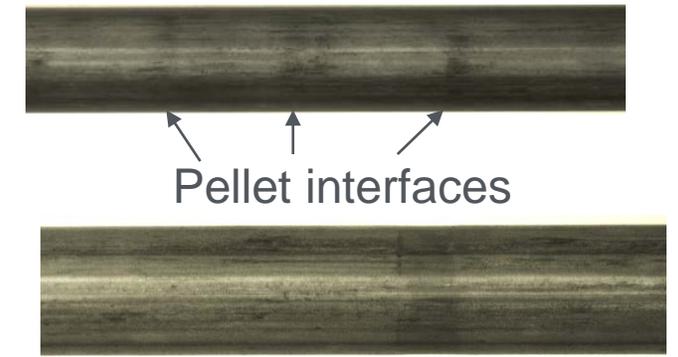
ZIRLO and M5 rods have the expected oxidized appearance;
Zirc-4 and LT Zirc-4 rods have heavy oxidation and some spallation;
many have grid-to-rod-fretting (GTRF) and pellet stack gaps

- Oxidation and CRUD levels varied among cladding alloys
- GTRF ranged from shallow to deep, but there were no observations of through-wall penetrations
- Pellet-to-pellet interfaces are often observable
- Pellet stack gaps were detected on nine rods ranging from 1 to 5 mm

Visible pellet stack gap ~5 mm

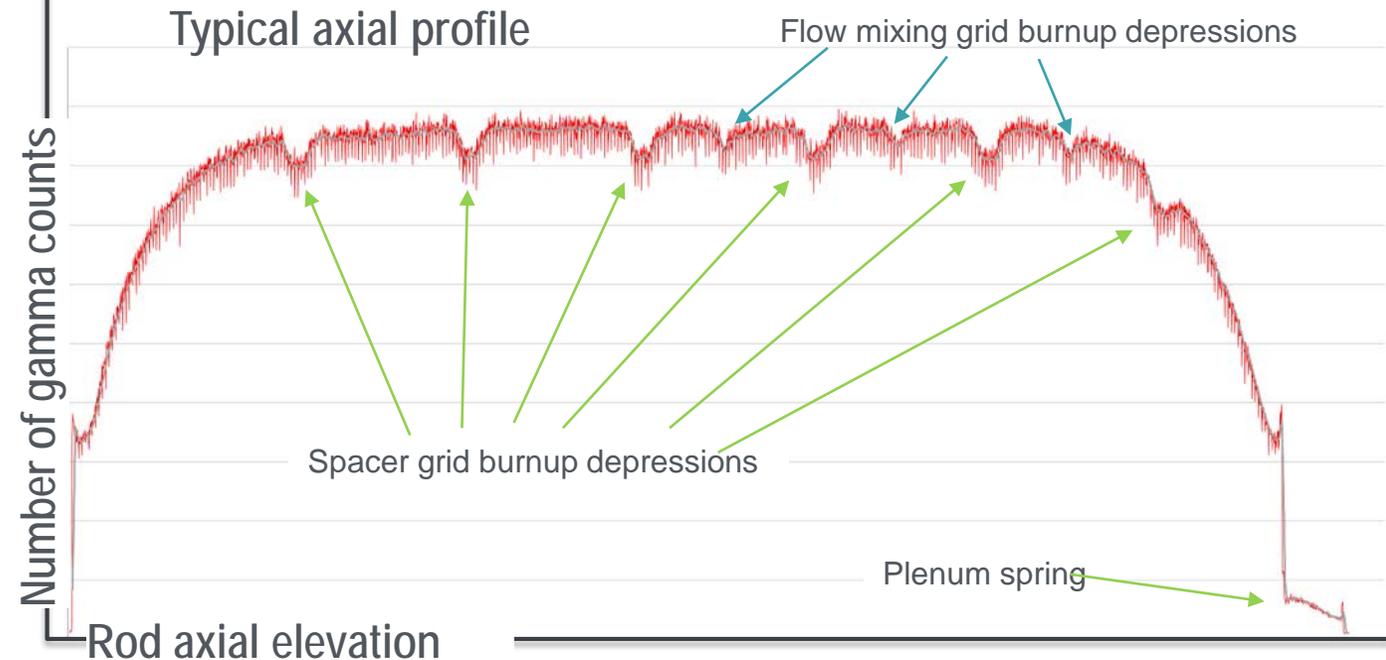
Axial burnup profiles were as expected, with depressions in burnup at spacer grid locations and pellets clearly discernable

- Gamma scanning was used to
 - Measure relative gamma activity as a function of axial position
 - Note burnup depressions that indicate spacer grid elevations
 - Determine pellet stack height
 - Identify individual pellets and locate any gaps between pellets
 - Support identification of cutting locations for destructive test specimens

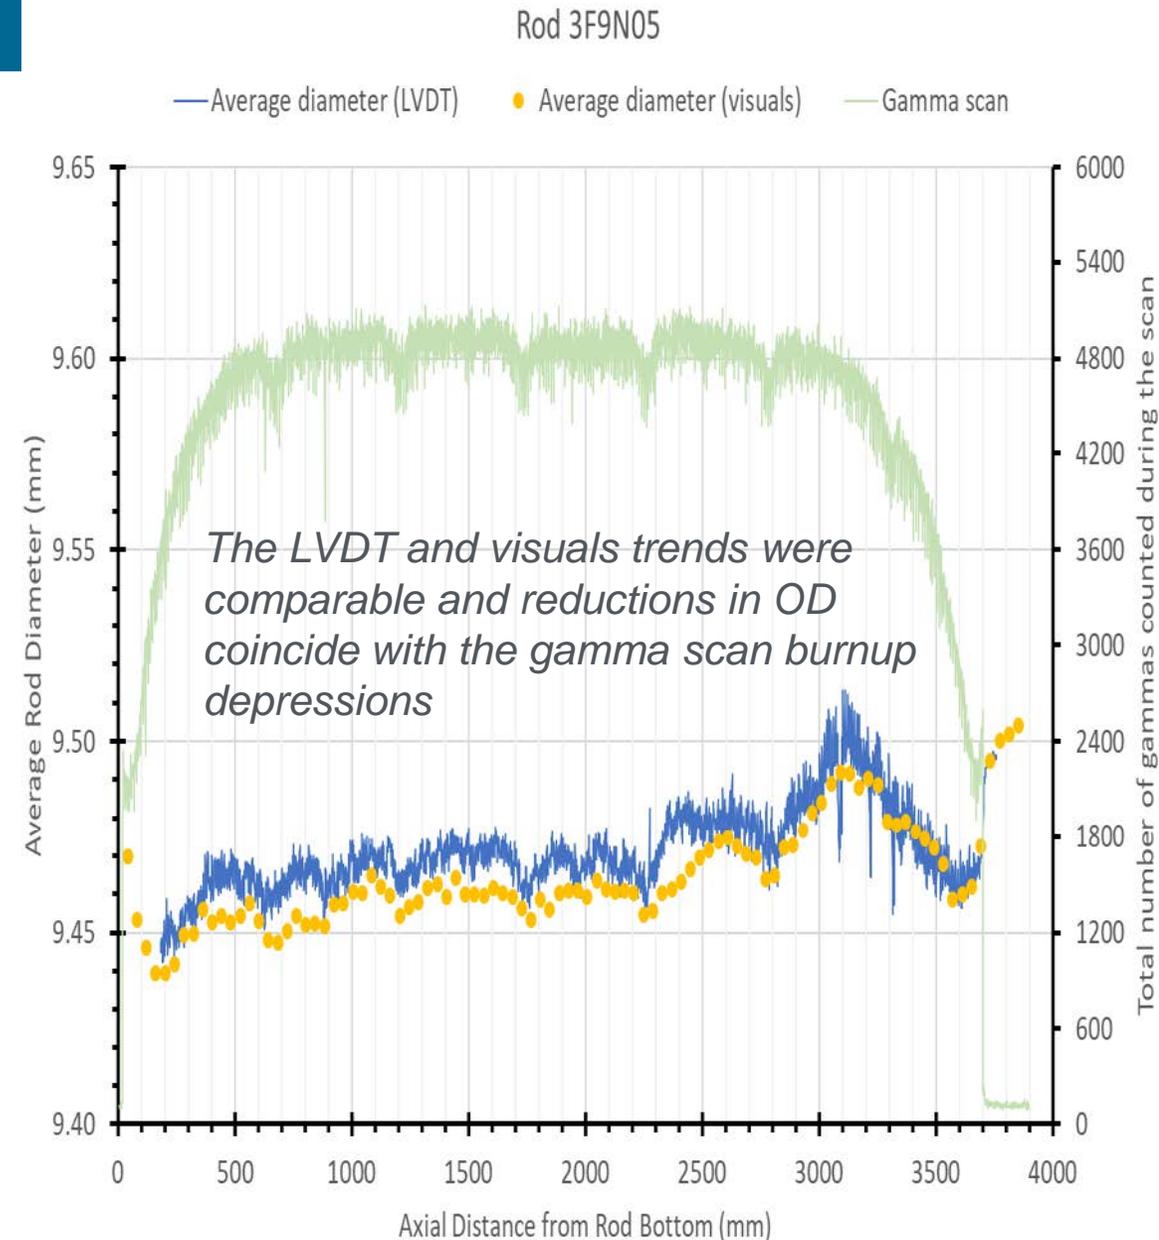
The rod's diameter follows the expected axial trend and is larger in HBU regions and smaller in lower-burnup regions

- The outer diameter of each sister rod was measured along its longitudinal axis in two ways
 - A pair of linear variable differential transformers (LVDTs) was used to obtain orthogonal measurements
 - ORNL developed an alternate diameter measurement technique utilizing the sister rod photographic database
 - A length-to-pixel ratio was determined by photographing a calibration rod

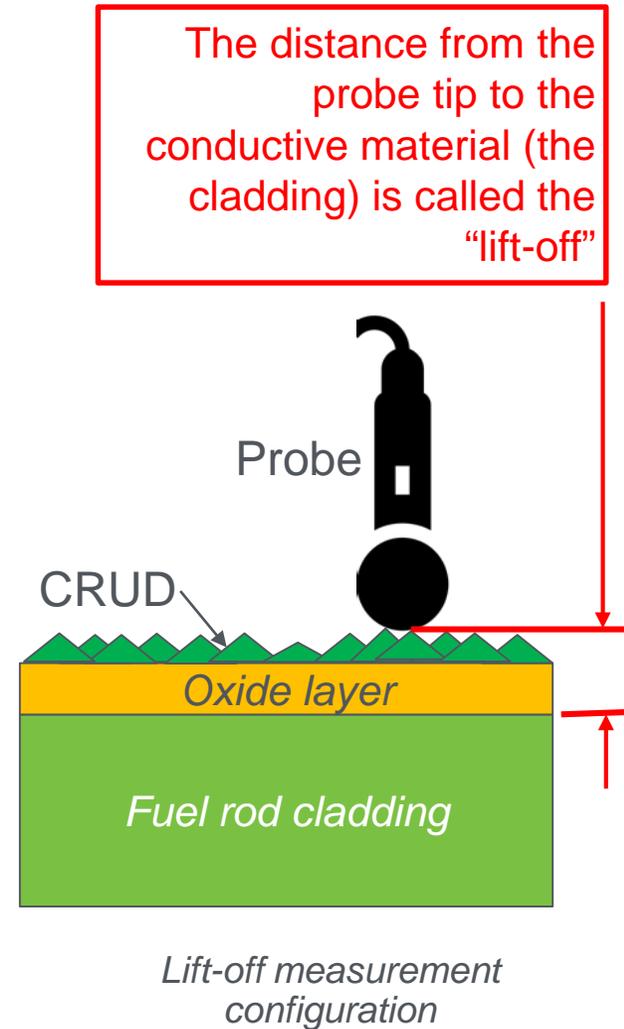
Eddy current scans were completed to measure lift-off and to look for cladding flaws

- Eddy current lift-off measurements use a contact probe to measure the distance from the probe tip to the electrically conductive surface (the fuel rod cladding)
- The measurement includes the thickness of any nonconductive surfaces between the probe tip and the cladding, including oxide, CRUD, and foreign material.
- Spalling oxide results in the indication of a thinner lift-off

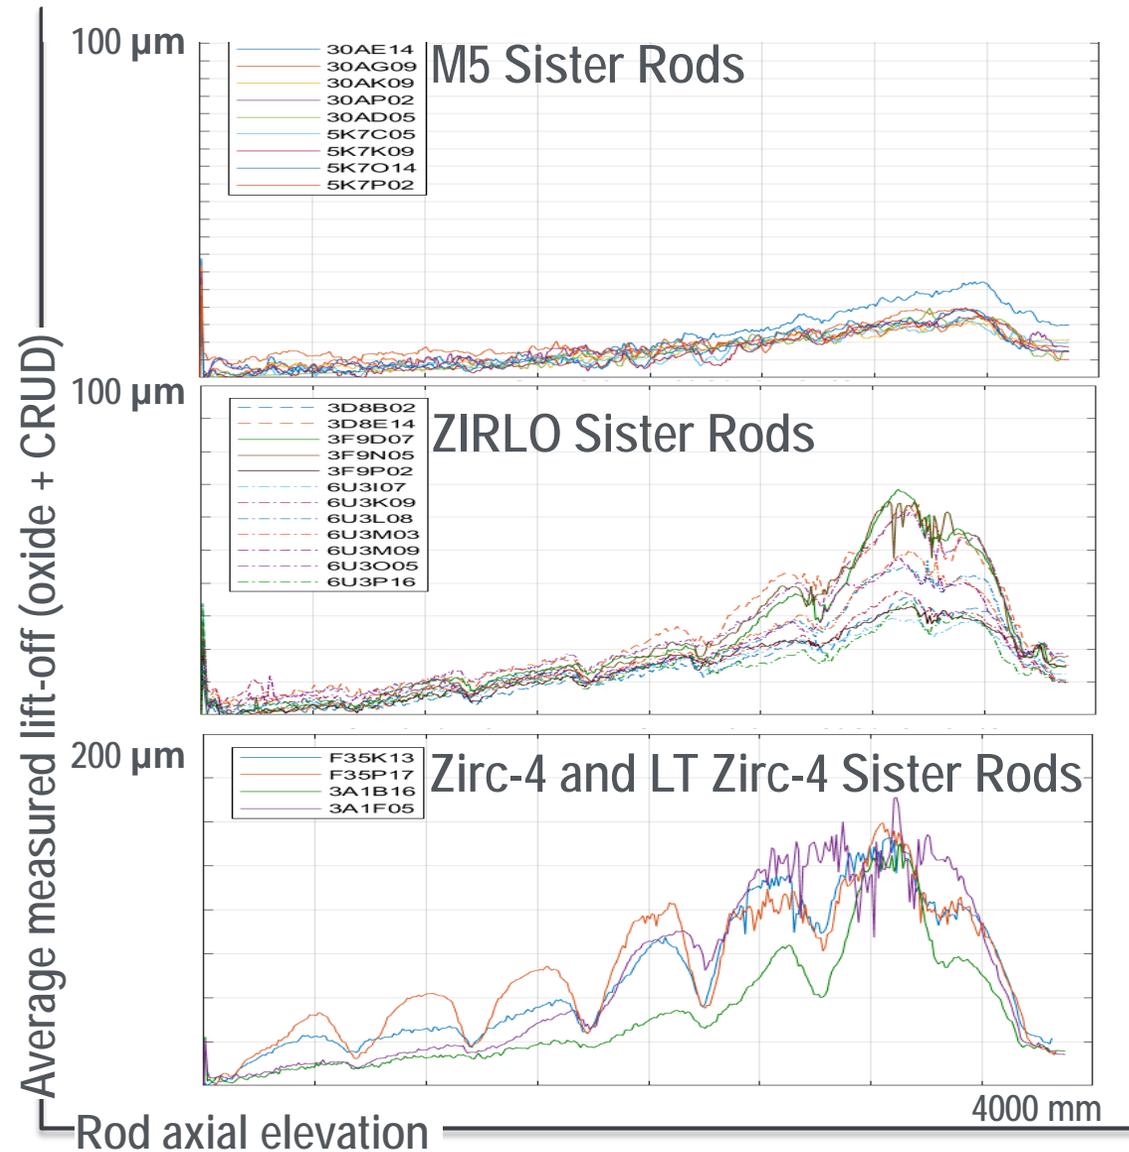
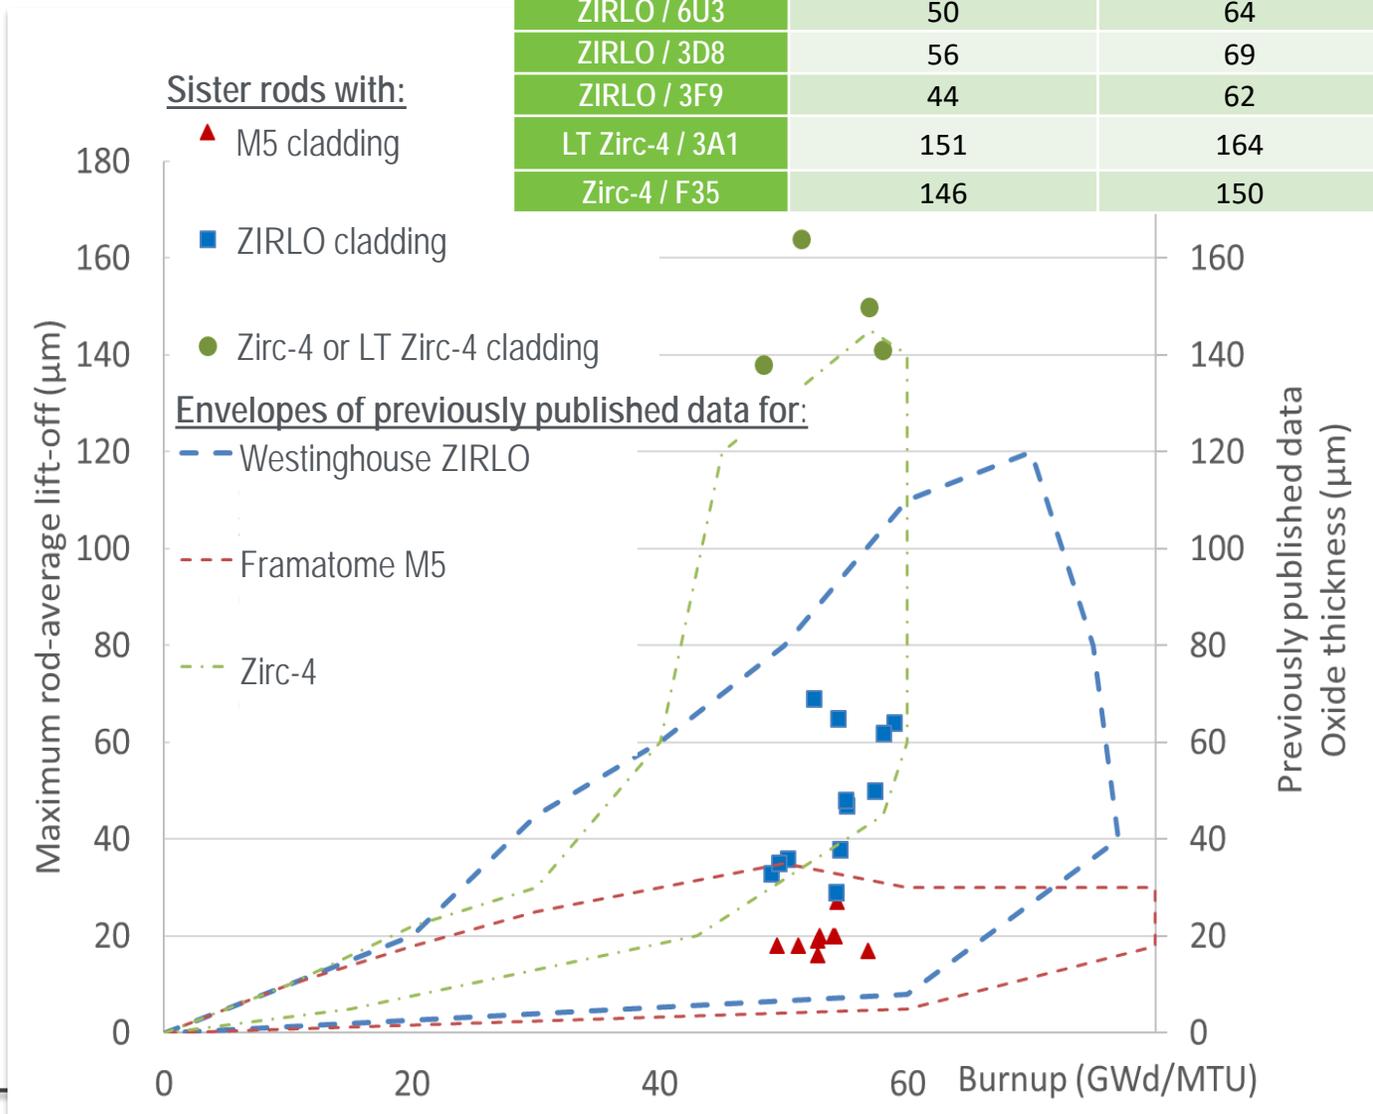
Average results were as expected, with the Zirc-4 and LT Zirc-4 clad rods having the highest lift-offs

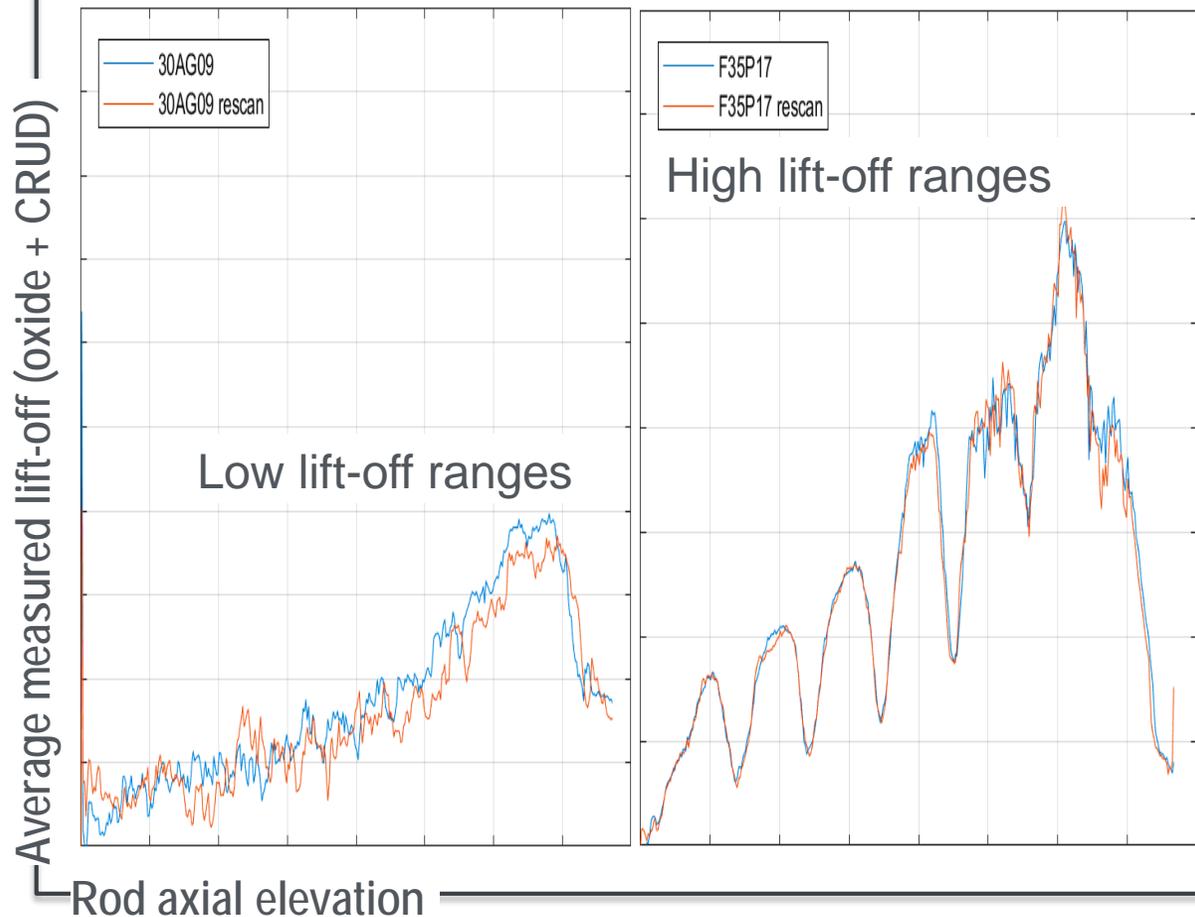
The ORNL lift-off measurements were repeatable, but are higher than other independent measurements

- Some rods were scanned using ORNL's system more than once and on different days, demonstrating very good repeatability

- EPRI performed a separate exam on the sister rods using a different set of eddy current coils (F-SECT) at discrete rod elevations
- Historical data available for two Zirc-4 F35 sister rods (circa 2002) indicates a lower average maximum lift-off, however, these two rods have a lot of spalling
- The metallography samples to be examined during the destructive examinations of the sister rods are expected to provide a definitive oxide thickness measurement for each sister rod

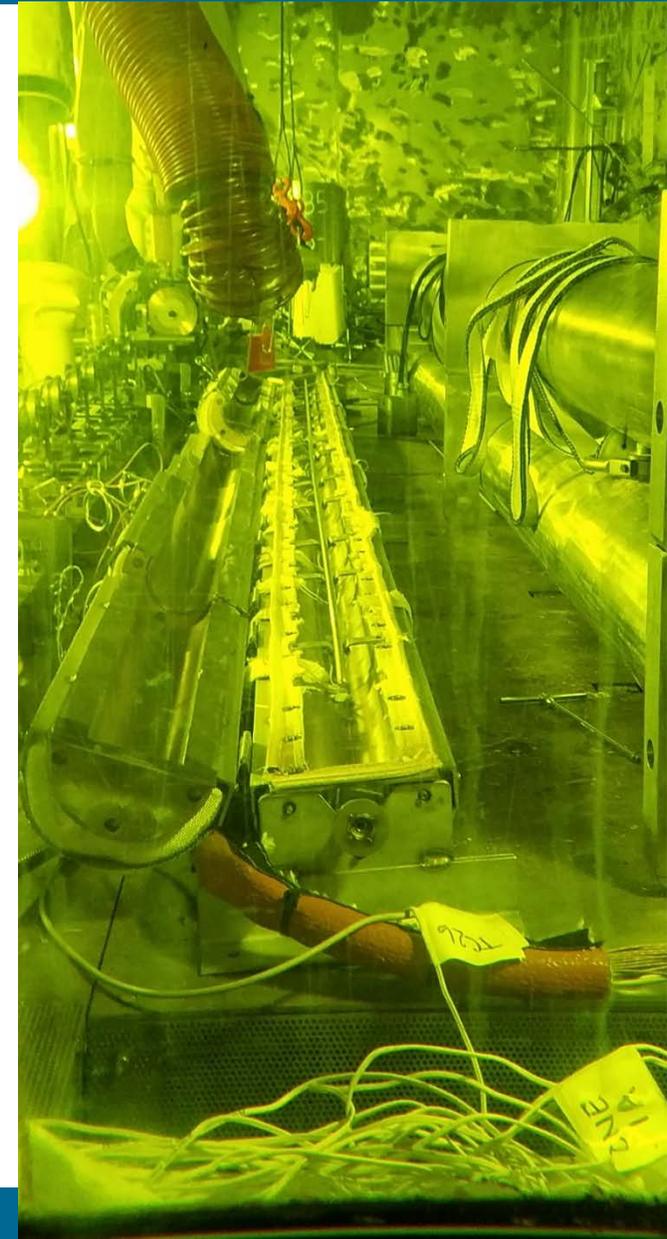
A specially designed heat treatment oven was used to simulate temperatures of dry storage vacuum drying on three sister rods—1 M5, 1 ZIRLO, and 1 Zirc-4

- The oven has seven zones using individual insulated heating blankets and is capable of multiple temperature profiles
- Each of the three selected sister rods was heat-treated using a flat axial profile at 400°C with a $\leq 5^\circ\text{C}$ cooldown rate
- Each rod heat treatment included approximately 38 h heatup + 8 h at temperature + 100 h cooldown
- The metallographic and mechanical test results from the heat-treated rods will be compared with the data from baseline rods to determine if vacuum drying imposes any changes on the cladding

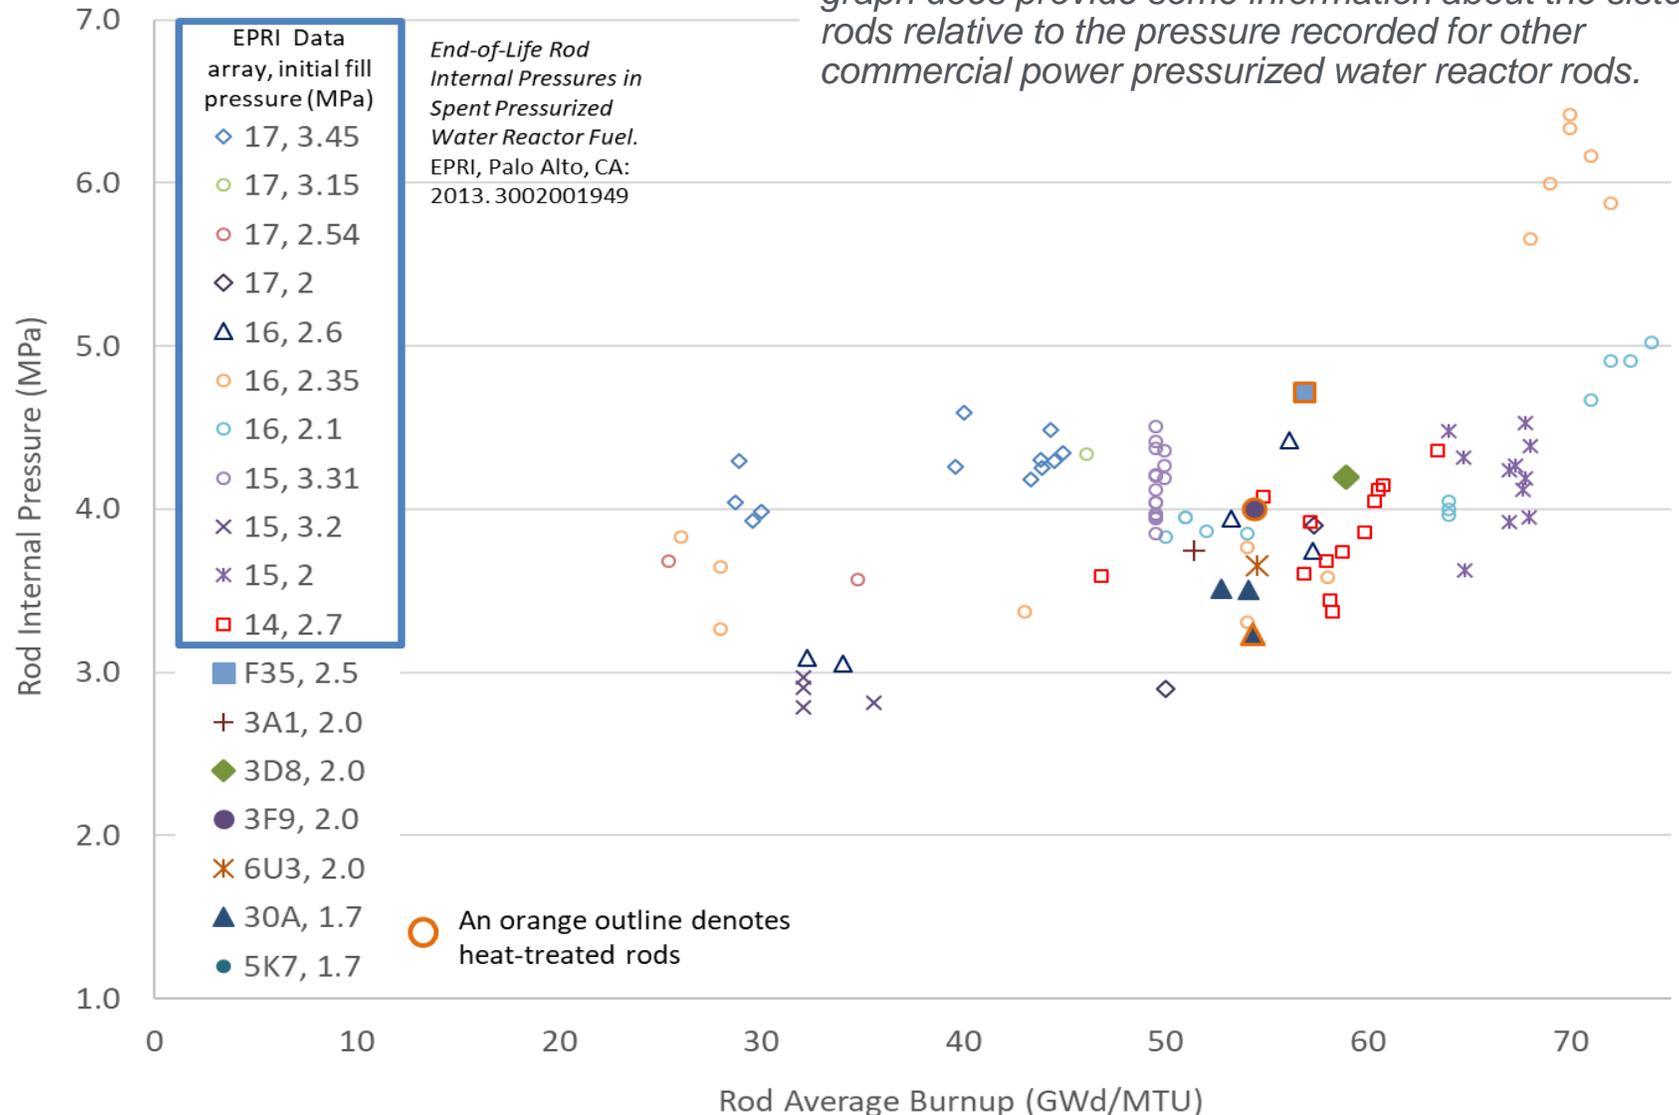
The rod internal pressures of eight sister rods have been measured and are between 3.2 and 4.7 MPa (464 to 682 psi) at 25°C

While the mechanical design of the sister rods is likely different from those presented in the EPRI report, the graph does provide some information about the sister rods relative to the pressure recorded for other commercial power pressurized water reactor rods.

- Data include Zirc-4, LT Zirc-4, M5, and ZIRLO
- All are within the envelope of past data
- No apparent effect of heat treatments

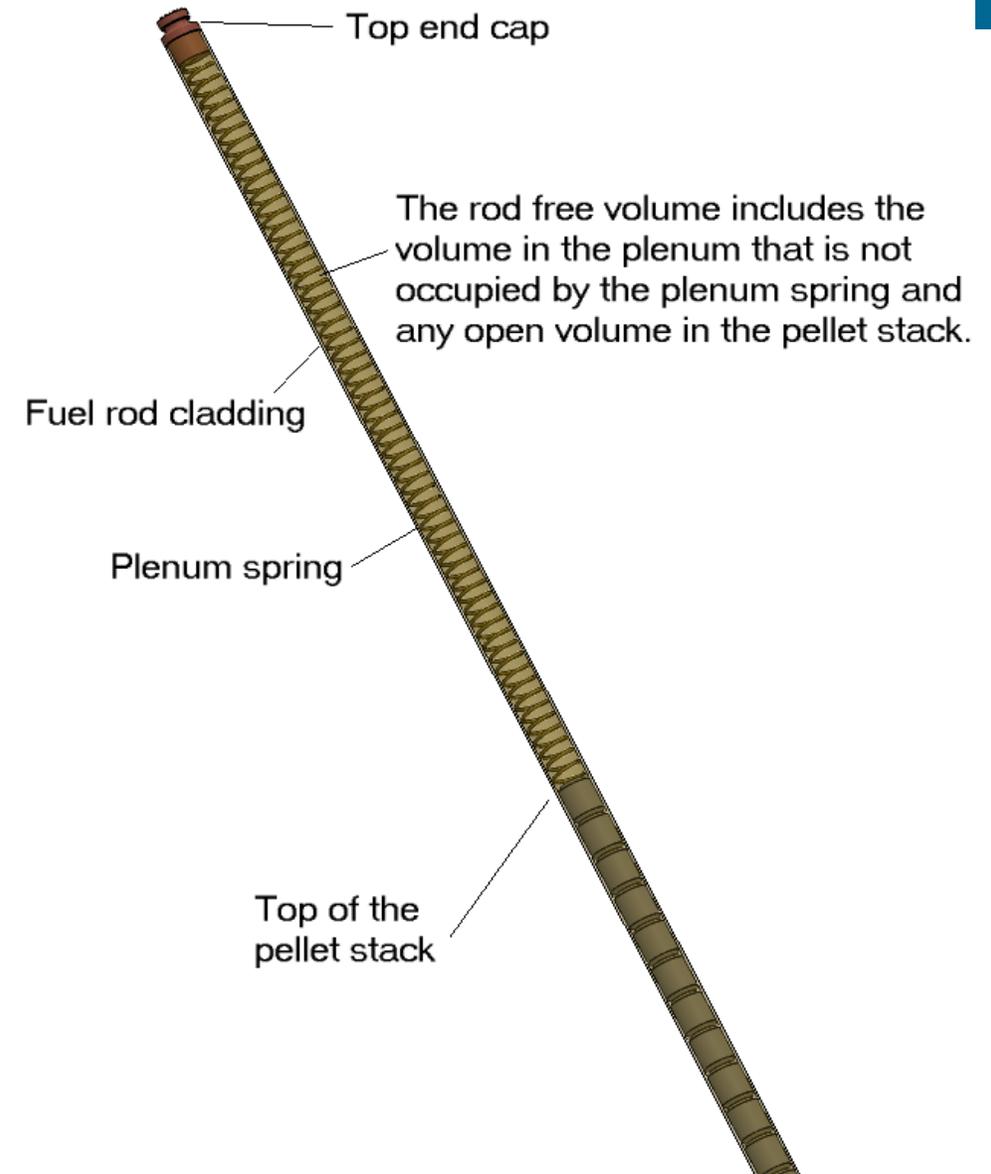
The internal free volumes of the eight sister rods measured to date are between 9.9 and 13.3 cc

- Data include Zirc-4, LT Zirc-4, M5, and ZIRLO-clad rods
- All are on the low side of past available data collected by EPRI [1] which ranges from 11.1 to 39.5 cc
 - *Rod free volume at end of life is largely dependent on the initial free volume*
 - *The mechanical design of the sister rods is likely different from the older fuel rod designs within the EPRI database.*
- No apparent effect of heat treatments

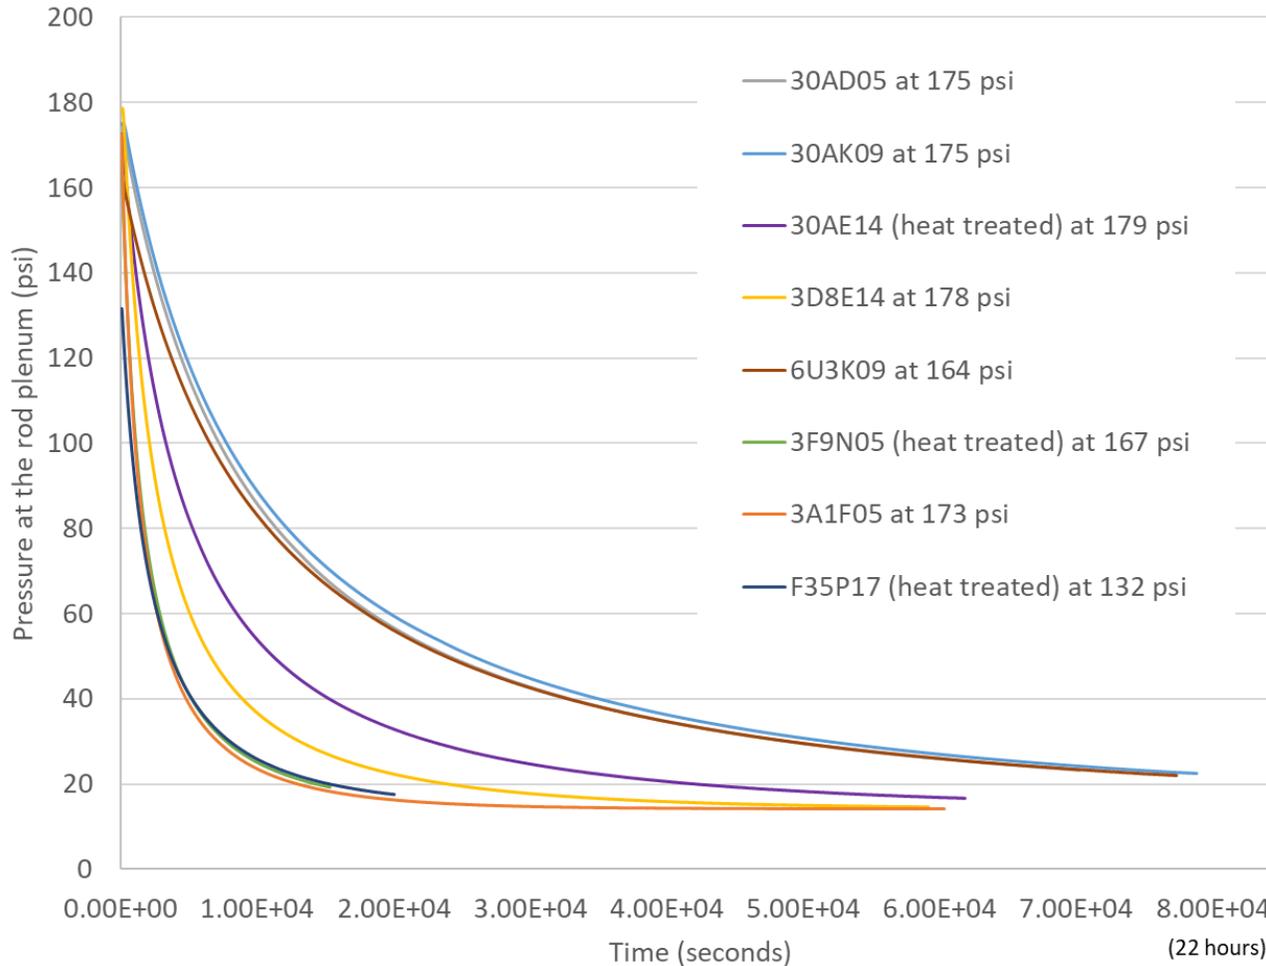
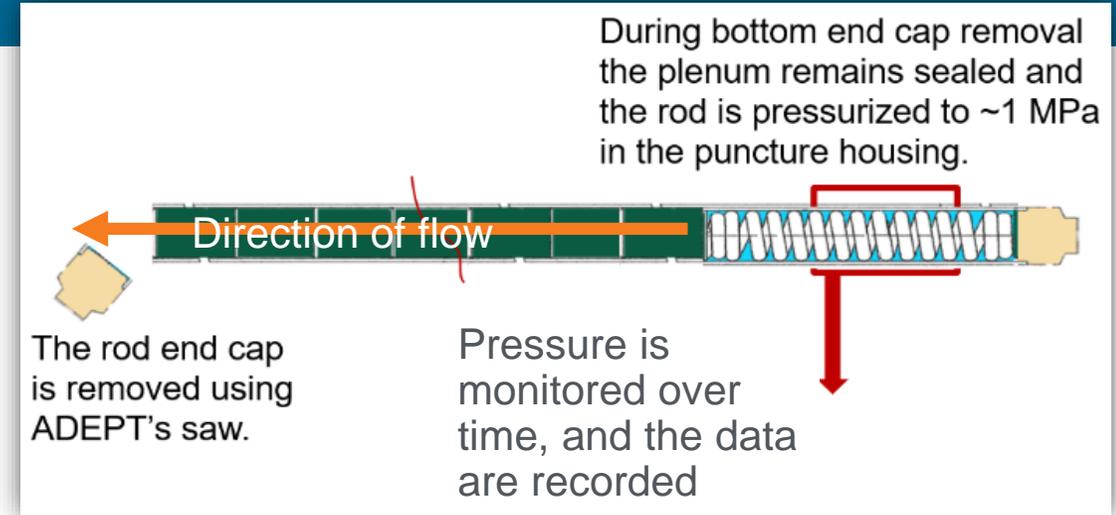
Decompression tests were first completed to determine if fission gases could flow freely through the full length of the fuel rod

- The rod plenum was pressurized, and the end was cut off the rod
- The pressure in the plenum was monitored over time
- A decrease in plenum pressure indicated that gas can flow through the pellet stack
- Eight full-length rods tested; no obvious difference for heat-treated rods

All rods had good communication along the entire pellet stack at room temperature (RT)
This test simulates a rod with a large leak

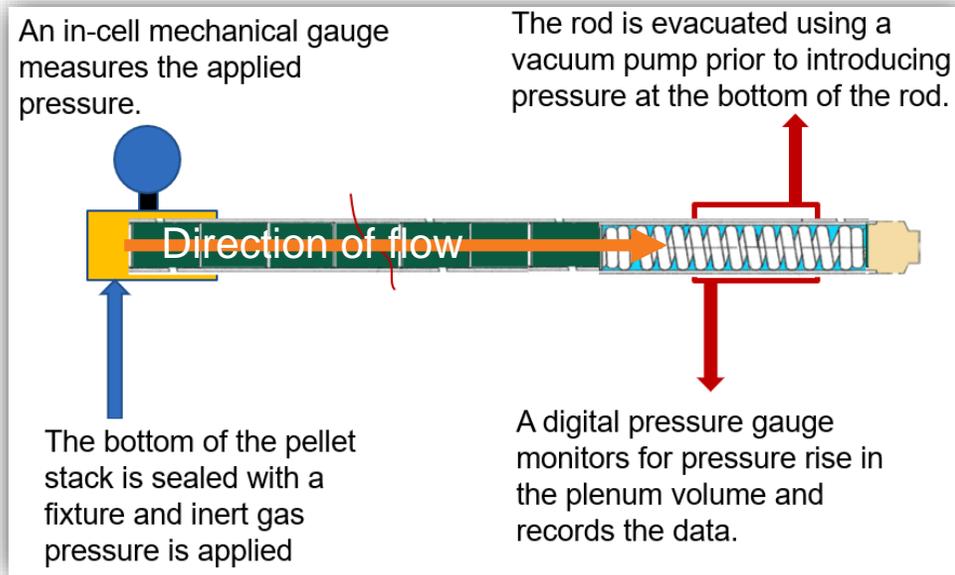
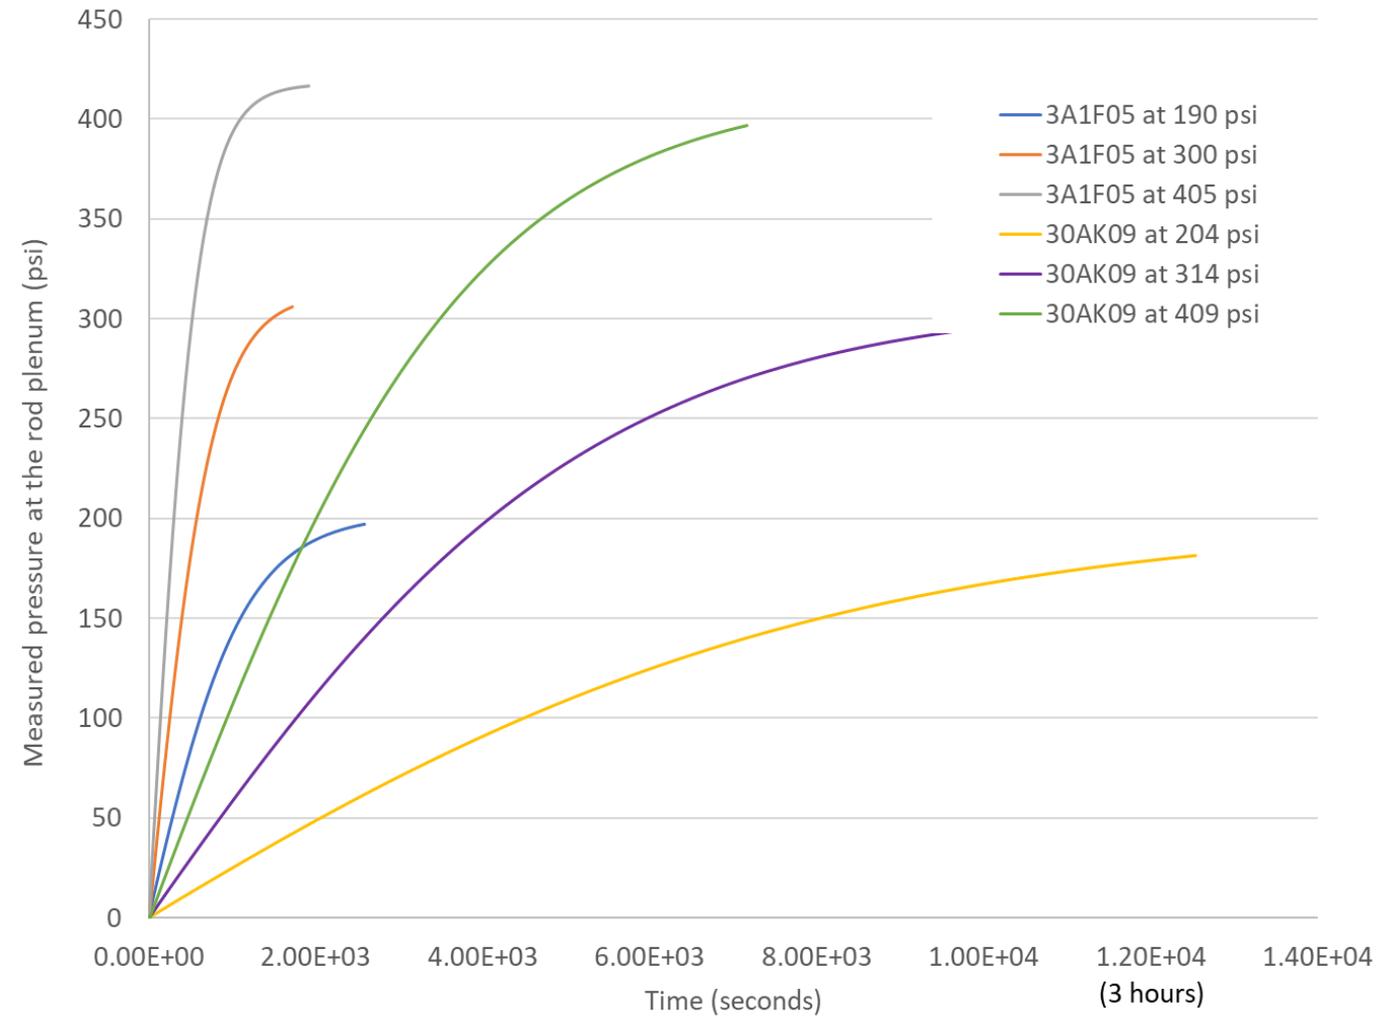
Gas transmission tests that applied pressure in the opposite direction were also completed

- Two full-length rods were tested
- Pressure was applied at the bottom of the pellet stack
- The pressure was monitored at the rod plenum

Both rods had good communication along the entire pellet stack at RT
