# DOE High Burnup Demonstration Project

NWTRB Fall Meeting  
Washington, DC  
November 19, 2019

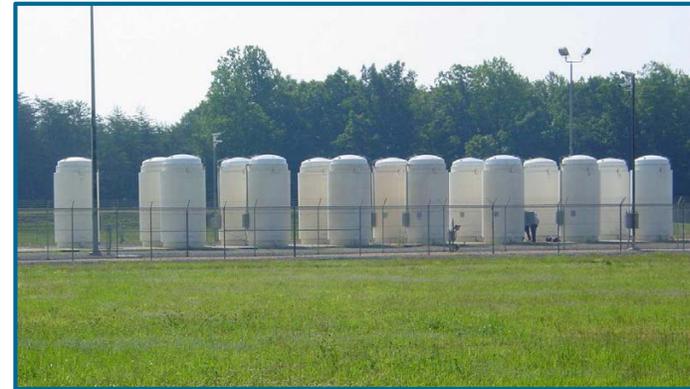
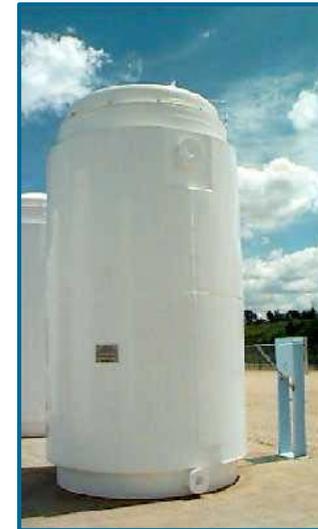
- *Initiated by DOE and industry collaborators to provide confirmatory data for models, future SNF dry storage cask designs, and to support license renewals and new licenses for ISFSIs.*
- Commercially-licensed TN-32 cask at North Anna ISFSI. Loaded with high burn-up spent fuel (4 common cladding alloys) in November, 2017.
- Cask monitored to determine thermal, environmental conditions experienced by the fuel during drying and storage.
  - Fuel cladding temperature (indirectly, via thermocouple lances)
  - Cavity gas pressure
  - Cavity gas composition (via periodic sampling after drying and filling with He backfill gas).

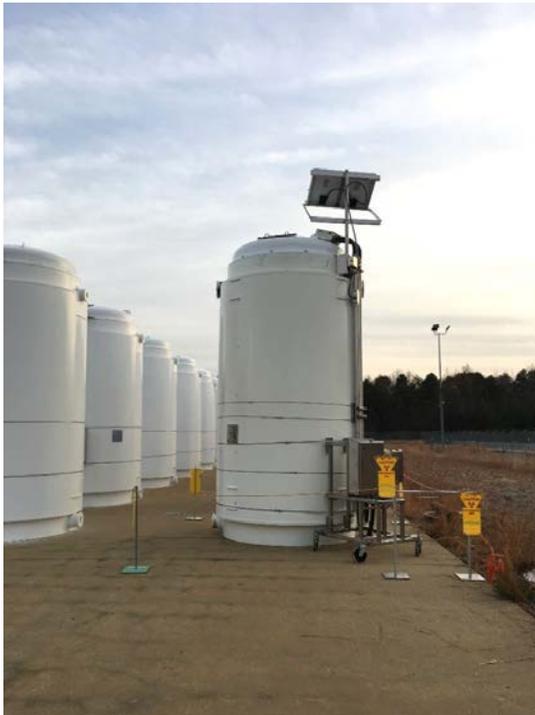
Loaded TN-32 for High Burnup Demo at North Anna

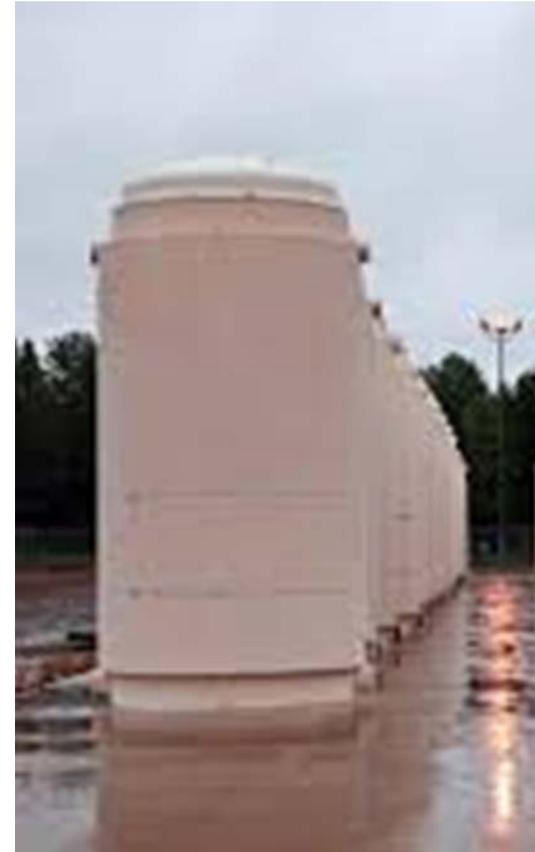
Picture from North Anna ISFSI

- He backfill gas, nominally 2.2 bars
- Sampled after filling, over a period of 12 days, to evaluate temporal changes in composition. Species analyzed:
- $^{85}\text{Kr}$ 
  - Indicator of damaged fuel (failed cladding)
  - Also dictates availability of other methods (radiological hazard status)
- $\text{H}_2\text{O}$ —used to evaluate:
  - Drying efficiency (e.g., ice formation)
  - Trapped water (dash pots, within failed fuel)
  - Chemisorbed and physisorbed water
- $\text{O}_2$ ,  $\text{N}_2$ ,  $\text{H}_2$ ,  $\text{CO}_2$ , other gases—provide metrics for:
  - Sample contamination by air
  - Chemical reactions (e.g., radiolysis, metal corrosion)
- Samples analyzed on-site at North Anna by Dominion Energy, duplicate samples sent to Sandia National Laboratories for more thorough analysis

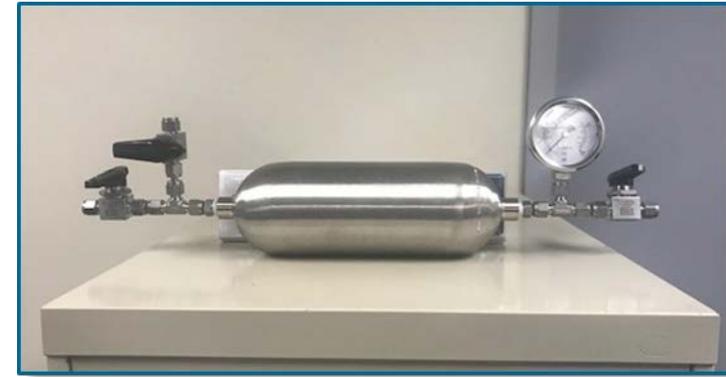
Bottles pretreated to remove sorbed water at SNL—heated to 80-90°C while being pumped at med-high vacuum ( $10^{-7}$  Torr) for 16-24 hours. Valving modified for SNL samples to allow longer storage.

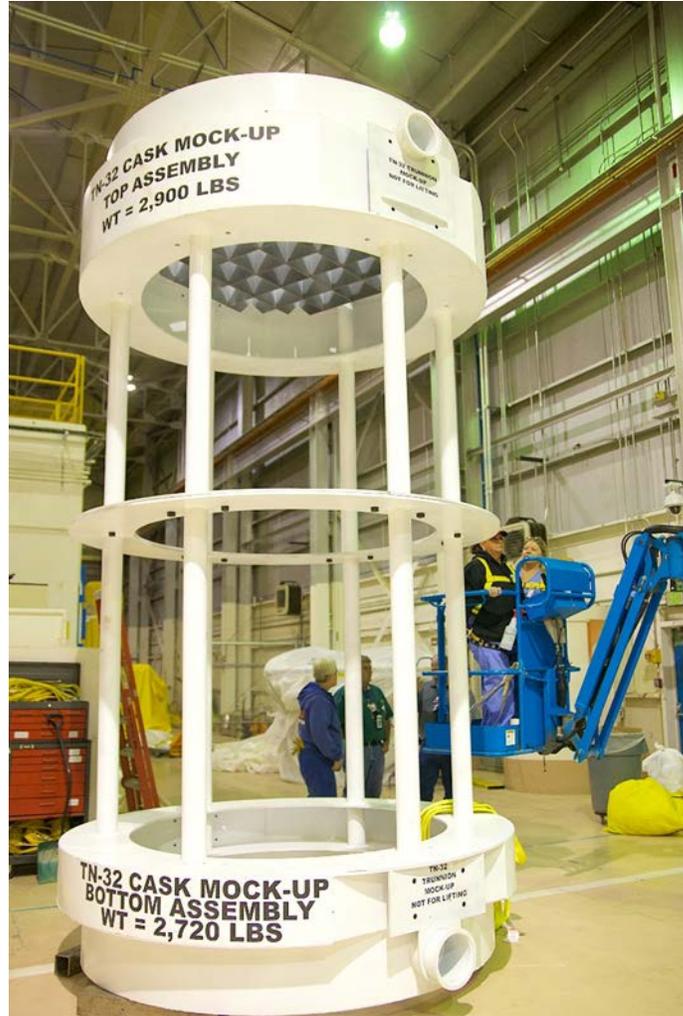
# Cask Mock Up of the TN-32 Cask

- Lidar was used to ensure clearance was possible
- A fit test was performed in the facility using a cask mock-up
- No problems were encountered that would indicate the facility cannot handle the real cask
